JOINT INVESTIGATION REPORT

INCIDENT NO: 2735619 JIV report S/N: 0593

1. Fountain Incident Number: 2735619 2. Type of incident* OIL SPILL
3. Name of Location 8" NIKALI - IMORIVER 2 DELIVERY LINE
4. Name of nearest community MUANYIMDCHI 5. State: RIVERS 6. LGA ETCITE
7. Production Facility/Installation CRUDE OIL DELIVERY LINE
8. Asset Owner/Hub THE SHELL PETROLEUM DEVELOPMENT COMPANY
OF NIGERIA LIMITED / PIPELINE

SECTION OF 8" NIKALI - IMORIVER2 DELIVERY LINE AT NIQUANTIMOUH ODAGWA SHOWING CRUDE OIL THEFT POINT INSTALLED AT 12 O'CLOCK POSITION BY UNKNOWN PERSON(S).

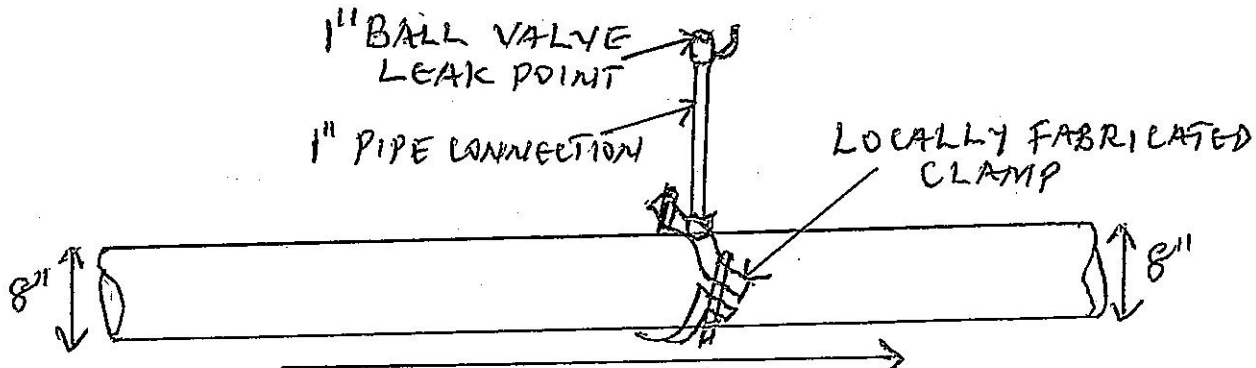
E. GRAPHIC DESCRIPTION OF LEAK POINT (while detailed description of the leak point should be contained in the leak report, overview sketch of the site should be added as appendix 1)

FROM NIKALI TO IMORIVER2

REPAIR ACTIVITIES ONGOING.

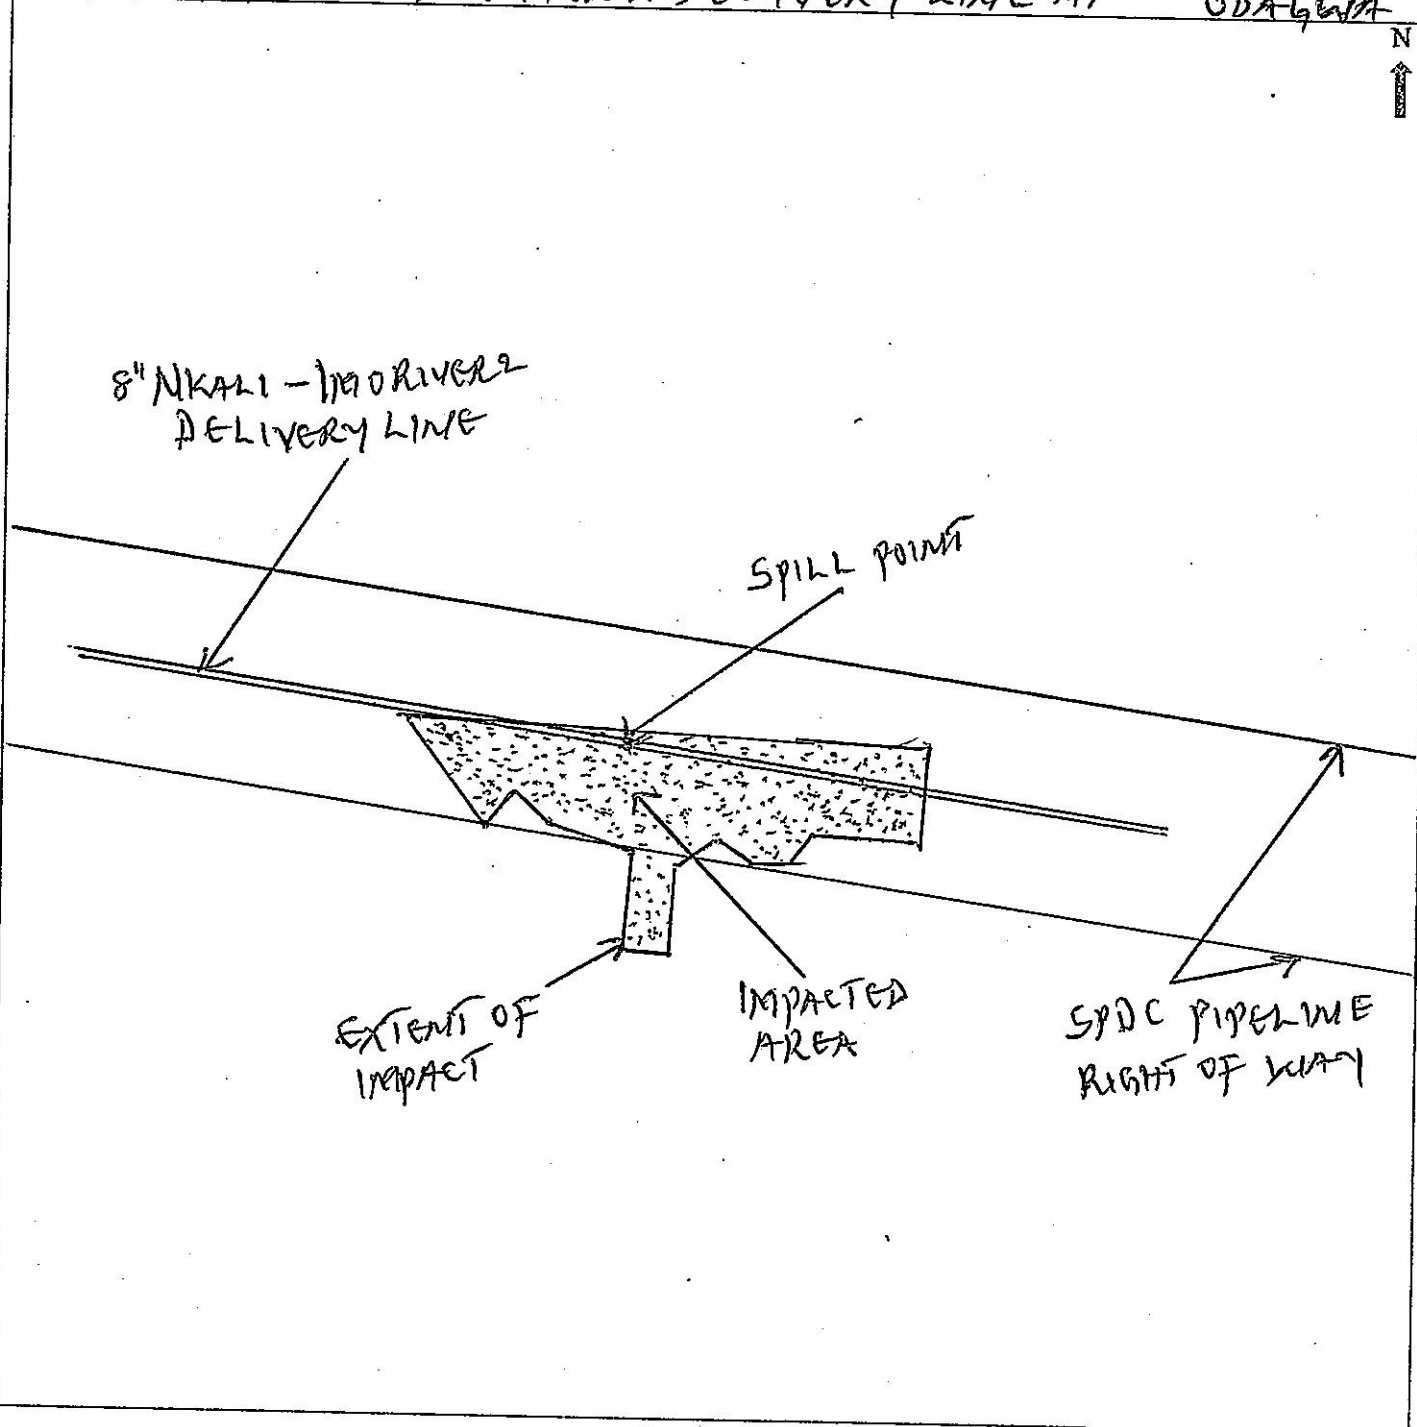
f. Appendix 1: Overview sketch of the site

Location: 8" NKALI - IMORIVERA DELIVERY LINE AT MUANYIMOTTA ODAGBWA
