# JOINT INVESTIGATION REPORT

INCIDENT NO: 2916110 JIV report S/N: 0000788

1. Fountain Incident Number: 2916110 2. Type of incident\* OIL SPILL  
3. Name of Location 14" OKORDIA - RUMUEKPE PIPELINE  
4. Name of nearest community IHUOKIO 5. State: RIVER 6. LGA AHOADA-EAST  
7. Production Facility/Installation OIL PIPELINE  
8. Asset Owner/Hub THE SHELL PETROLEUM DEVELOPMENT COMPANY OF NIGERIA LIMITED (SPDC)/PIPELINE

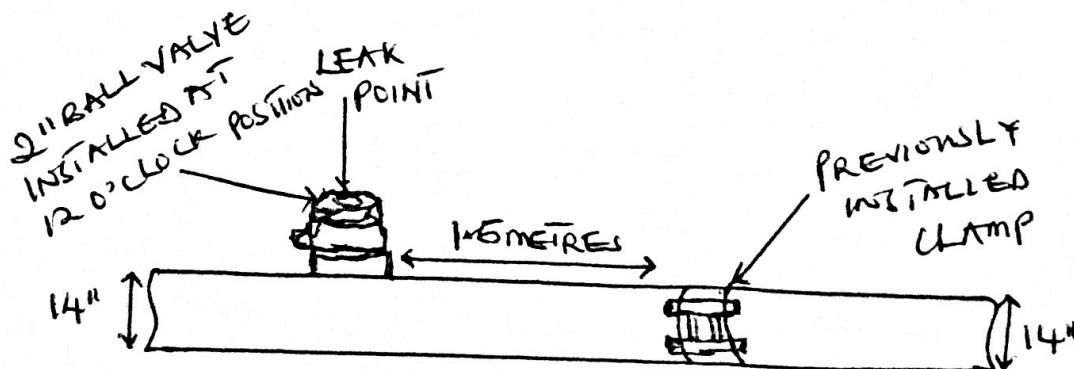
**E. GRAPHIC DESCRIPTION OF LEAK POINT** (while detailed description of the leak point should be contained in the leak report, overview sketch of the site should be added as appendix 1)

A SECTION OF 14" OKORDIA - RUMUEKPE PIPELINE AT IHUONO SHOWING A 2" BALL VALVE INSTALLED AT 12 O'CLOCK POSITION BY UNKNOWN PERSONS CLOSE TO A PREVIOUSLY INSTALLED CLAMP.

REPAIR ACTIVITY BY CLAMPING
