JOINT INVESTIGATION REPORT

INCIDENT NO: 2920756 JIV report S/N: 0000837

1. Fountain Incident Number: 2920756 2. Type of incident* OIL SPILL
3. Name of Location 28" NKPOKU - BOMU PIPELINE
4. Name of nearest community AGBONCHIA 5. State: RIVERS 6. LGA ELEME
7. Production Facility/Installation CRUDE OIL PIPELINE
8. Asset Owner/Hub THE SHELL PETROLEUM DEVELOPMENT COMPANY
OF NIGERIA LIMITED / PIPELINE

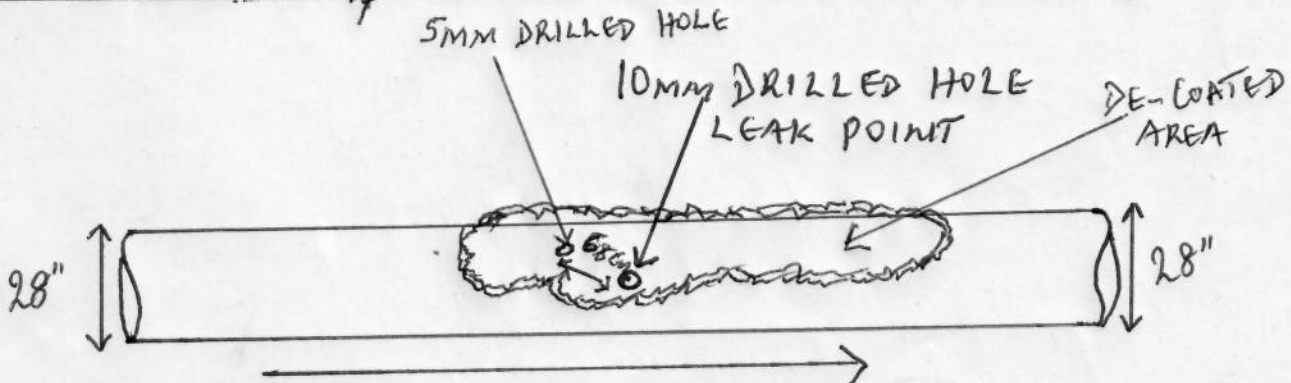
| <input checked="" type="checkbox"/> Others (specify) <u>DRILLED HOLES</u> | | |

SECTION OF 28" MKPOKU - BOMU PIPELINE AT AGBONCHIA SHOWING DRILLED HOLE AT 3 O'CLOCK POSITIONS BY UNKNOWN PERSONS

FROM NKPOKU TO BOMU

RESPONSE AND REPAIR WORK ONGOING.
