# JOINT INVESTIGATION REPORT

INCIDENT NO: 2921911 JIV report S/N: 0000842

1. Fountain Incident Number: 2921911 2. Type of incident\* OIL SPILL  
3. Name of Location 20" KOLO CREEK - RUMUEKPE PIPELINE  
4. Name of nearest community OKPOROWO 5. State: RIVERS 6. LGA AITOADA EAST  
7. Production Facility/Installation PIPELINE  
8. Asset Owner/Hub THE STELL PETROLEUM DEVELOPMENT COMPANY OF NIGERIA LIMITED (SPDC)/PIPELINE

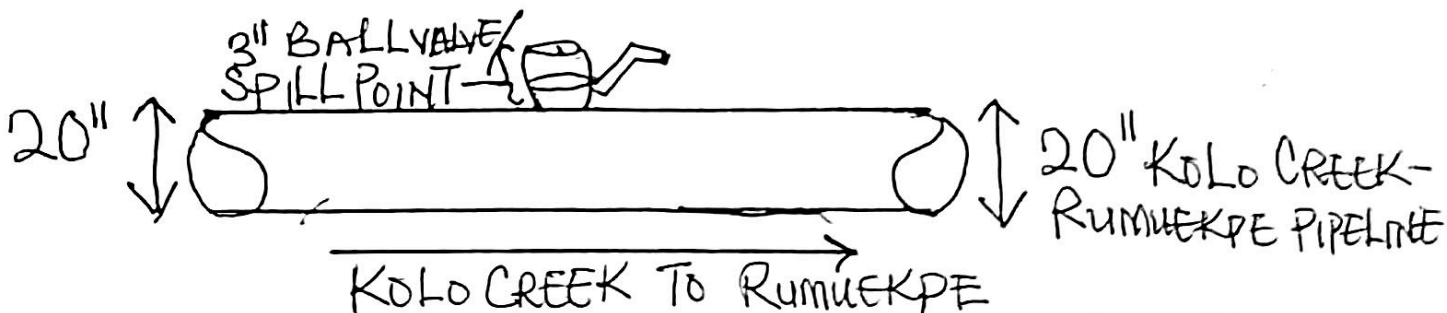
**E. GRAPHIC DESCRIPTION OF LEAK POINT** (while detailed description of the leak point should be contained in the leak report, overview sketch of the site should be added as appendix 1) A SECTION OF 20" KOLO CREEK-RUMUEKPE PIPELINE AT OKPOROWO SHOWING 3" ILLEGAL BALL VALVE INSTALLED AT 12 O' CLOCK POSITION BY UNKNOWN PERSON(S).

ON 13<sup>th</sup> APRIL, 2021, AT ABOUT 14:20 HRS, DURING JIV CRUDE OIL LEAK WAS OBSERVED FROM AN EARLIER REPORTED NON-LEAKING ILLEGAL CONNECTION (FD 2731473) ON 20" KOLO CREEK - RUMUEKPE PIPELINE AT OKPOROWO. THE BURNT VEGETATION IS AS A RESULT OF PREVIOUS ILLEGAL MINING ACTIVITIES AROUND THAT AREA
