# JOINT INVESTIGATION REPORT

INCIDENT NO: 3015154 JIV report S/N: 0000957

1. Fountain Incident Number: 3015154 2. Type of incident\* OIL SPILL  
3. Name of Location 20" KOLO CREEK - RUMUEKPE PIPELINE  
4. Name of nearest community OKOMA1 5. State: RIVERS 6. LGA AITHADA EAST  
7. Production Facility/Installation CRUDE OIL PIPELINE  
8. Asset Owner/Hub THE SHELL PETROLEUM DEVELOPMENT COMPANY OF NIGERIA LIMITED (SPDC)/PIPELINE

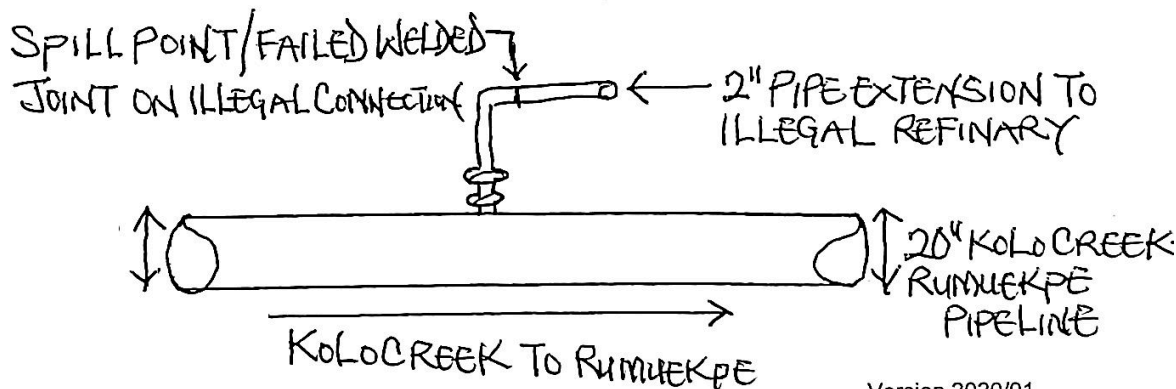
A LEAKING 2" PIPE FROM ILLEGAL REFINARY FITTED TO THE 20" PIPELINE.

E. GRAPHIC DESCRIPTION OF LEAK POINT (while detailed description of the leak point should be contained in the leak report, overview sketch of the site should be added as appendix 1) A SECTION OF 20" KOLO CREEK RUMUEKPE PIPELINE AT OKOMA 1 SHOWING A 2" BALL VALVE AND FITTED WITH A 2" PIPE, INSTALLED AT 12 O'CLOCK POSITION BY UNKNOWN PERSON(S).
