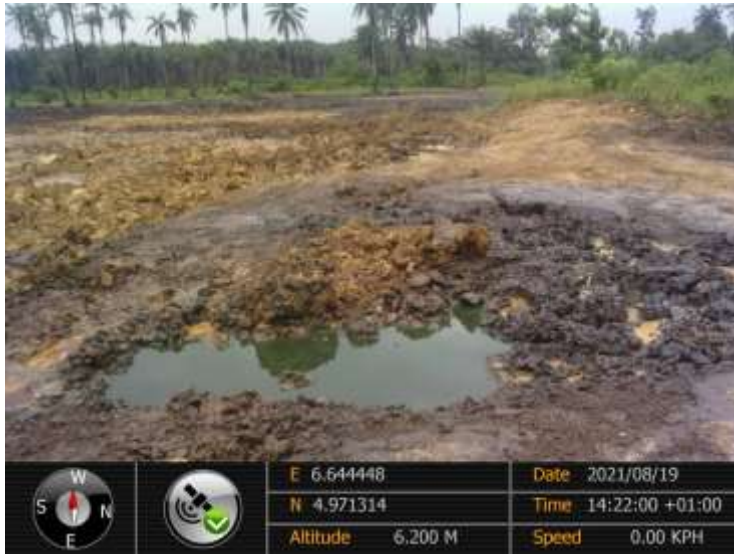
Overview: Part of spill impact on 20" Kolocreek Rumuekpe Pipeline at Okoma 1.
 Picture was taken during Joint Investigation of 19th August 2021.

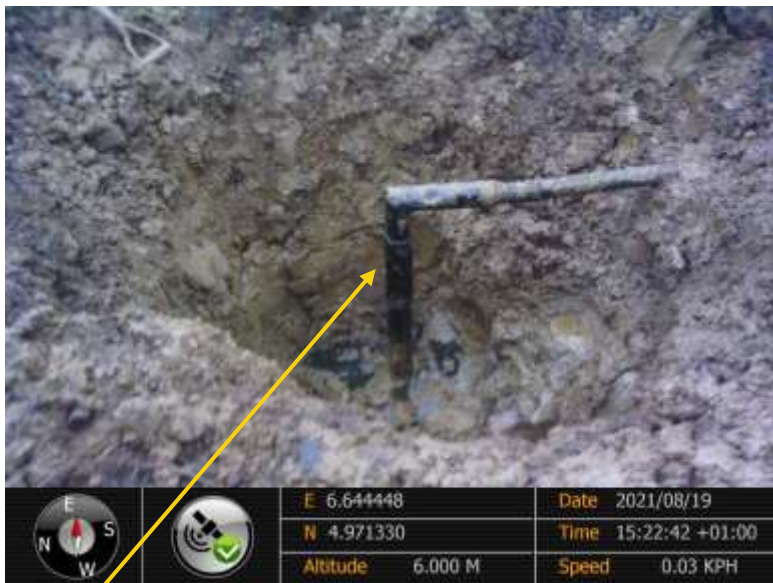
Close-up: 2inch ball valve and 2inch pipe installed at 12 o'clock position on 20" Kolocreek Rumuekpe Pipeline at Okoma 1.
 Picture was taken during Joint Investigation of 19th August 2021.
