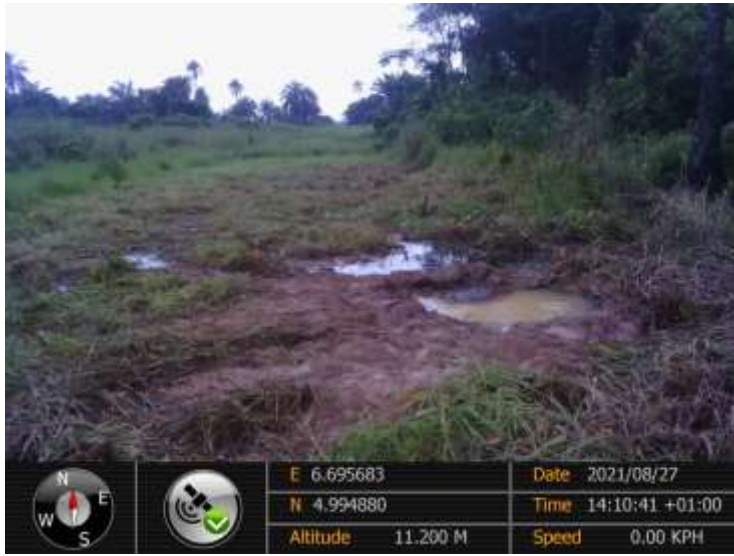
Overview: Part of spill impact on 18" Kolocreek Rumuekpe Pipeline at Rumuekpe. Picture was taken during Joint Investigation of 27th August 2021.

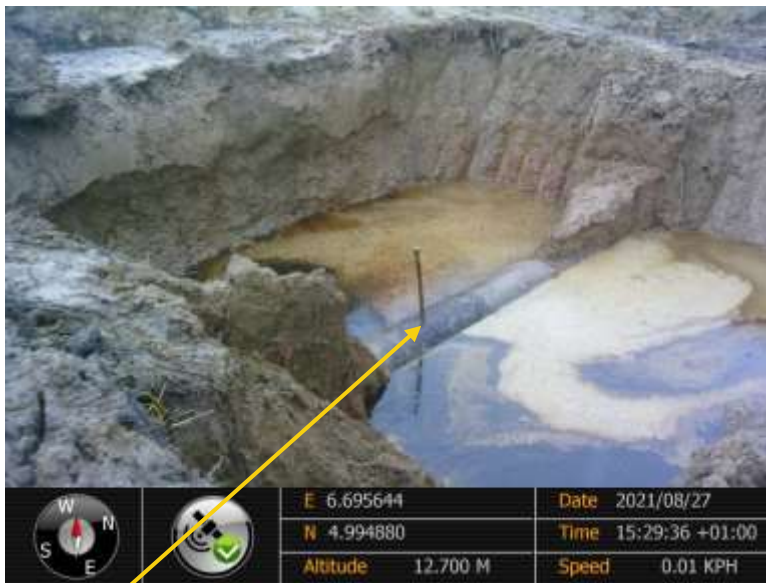
Close-up: Plugged 20mm diameter smooth round edge hole at 12 o'clock position on 18" Kolocreek Rumuekpe Pipeline at Rumuekpe. Picture was taken during Joint Investigation of 27th August 2021.
