Overview: Part of spill impact on 14" Okordia Rumuekpe Pipeline at Akara-Olu. Picture was taken during Joint Investigation of 29th August 2021.

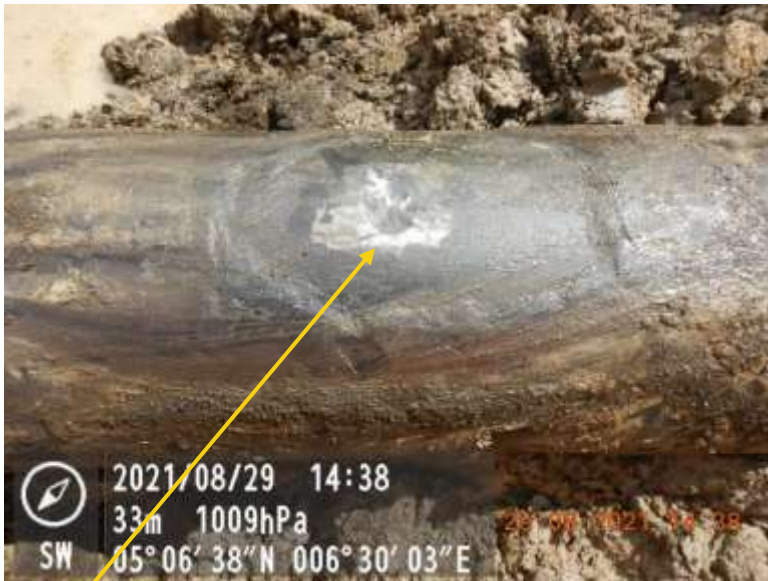
Close-up: 60mm diameter inward dent at 12 o'clock position on 14" Okordia Rumuekpe Pipeline at Akara-Olu. Picture was taken during Joint Investigation of 29th August 2021.
