**Overview:** Part of spill impact on Forcados Single Point Mooring 2 at Ogulagha.  
 Picture was taken during Joint Investigation of 16<sup>th</sup> August 2021.

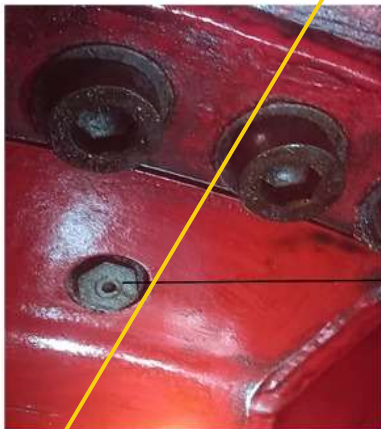
3/4" NPT SPECIAL PLUG (5mm dia. Hole)

Below picture shows the Nipple of interest on SBM2.  
 PDU Assembly drawing is as attached, Item #06 is the point of leak.  
 See the note section for description.

**Close-up :** Failed special plug nipple on Forcados Single Point Mooring 2 at Ogulagha.  
 Picture was taken during Joint Investigation of 16<sup>th</sup> August 2021.
