JOINT INVESTIGATION REPORT

INCIDENT NO: 3069741 JIV report S/N: 0000991

1. Fountain Incident Number: 3069741 2. Type of incident* OIL SPILL
3. Name of Location 36" NKPOKU - BOMU PIPELINE
4. Name of nearest community ENEKA 5. State: RIVERS 6. LGA OBIO/AKPOR
7. Production Facility/Installation OIL PIPELINE
8. Asset Owner/Hub THE SHELL PETROLEUM DEVELOPMENT COMPANY OF NIGERIA LIMITED (SPDL) / PIPELINE

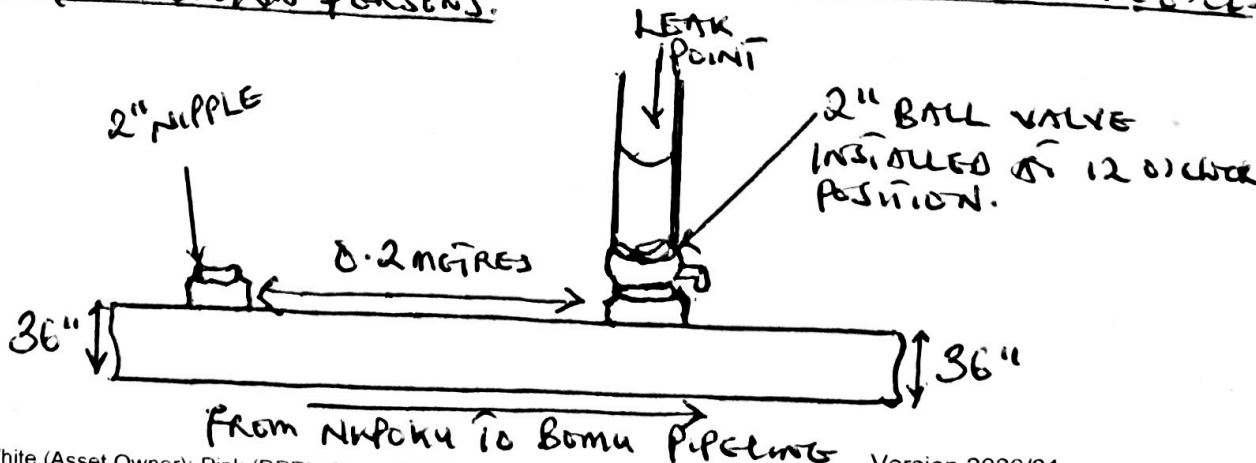
E. GRAPHIC DESCRIPTION OF LEAK POINT (while detailed description of the leak point should be contained in the leak report, overview sketch of the site should be added as appendix 1)

BOMU PIPELINE AT ENKA SHOWING A 2" BALL VALVE AND A 2" NIPPLE WITH A DISTANCE OF 0.2 METRES APART INSTALLED AT 12 O'CLOCK POSITION BY UNKNOWN PERSONS.

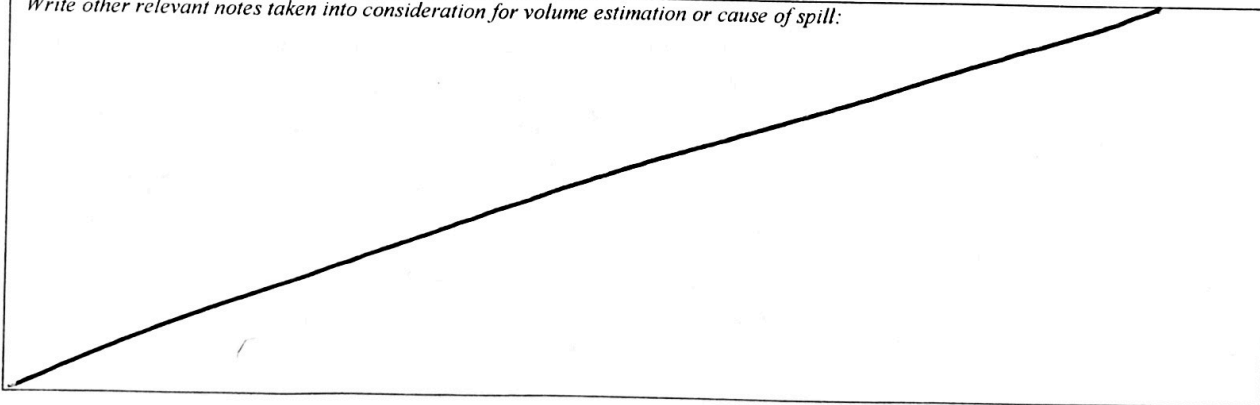
Write other relevant notes taken into consideration for volume estimation or cause of spill:

c. Net Estimated Spilled Volume $V_{\text{Est}}(\text{bbbls})^* =$ 0.97 BARREL

- Volume estimation was done using an excel based tool. (see attached for details on the calculation)
- Reported spilled volume is an estimate
