# JOINT INVESTIGATION REPORT

INCIDENT NO: 3071665 JIV report S/N: 001106

1. Fountain Incident Number: 3071665 2. Type of incident\* OIL SPILL  
3. Name of Location 6" IMB RINGR WELL 59T FLOWLINE  
4. Name of nearest community IGIRUKWU (ONAZA) 5. State: ABIA 6. LGA UKWA-WEST  
7. Production Facility/Installation FLOWLINE  
8. Asset Owner/Hub TITE STEEL PETROLEUM DEVELOPMENT COMPANY OF NIGERIA LIMITED (SPOC) / LAND EAST HUB

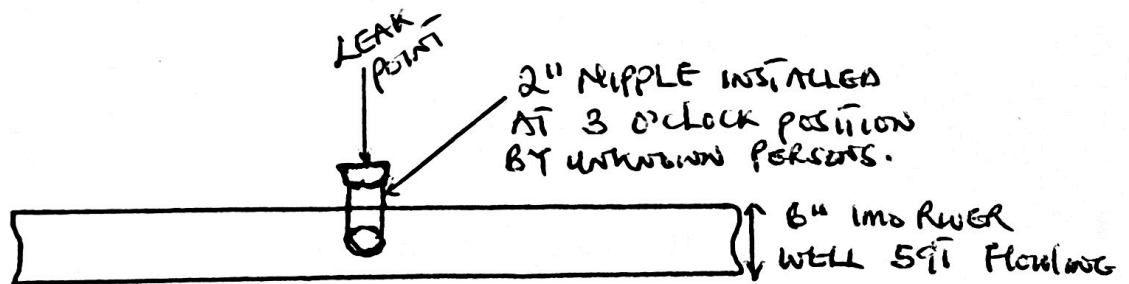
**E. GRAPHIC DESCRIPTION OF LEAK POINT** (while detail report of the leak point should be contained in the leak report, overview sketch of the site should be added as an appendix 1) A SECTION OF 6" IMB RIVER WELL 591 FLOWING AT GIRIKWU (OWAZA) SHOWING A 2" NIPPLE INSTALLED AT 3 O'CLOCK POSITION DONE BY UNKNOWN PERSONS.
