JOINT INVESTIGATION REPORT

INCIDENT NO: 3072842 JIV report S/N: 0001105

1. Fountain Incident Number: 3072842 2. Type of incident* OIL SPILL
3. Name of Location 4" IMO RIVER WELL 64L FLOWLINE
4. Name of nearest community IGIRIKKWA (CONAZA) 5. State: ABIA 6. LGA UKWA - WEST
7. Production Facility/Installation FLOWLINE
8. Asset Owner/Hub THE SHELL PETROLEUM DEVELOPMENT COMPANY OF NIGERIA LIMITED (SPDC) / LAND EAST HUB

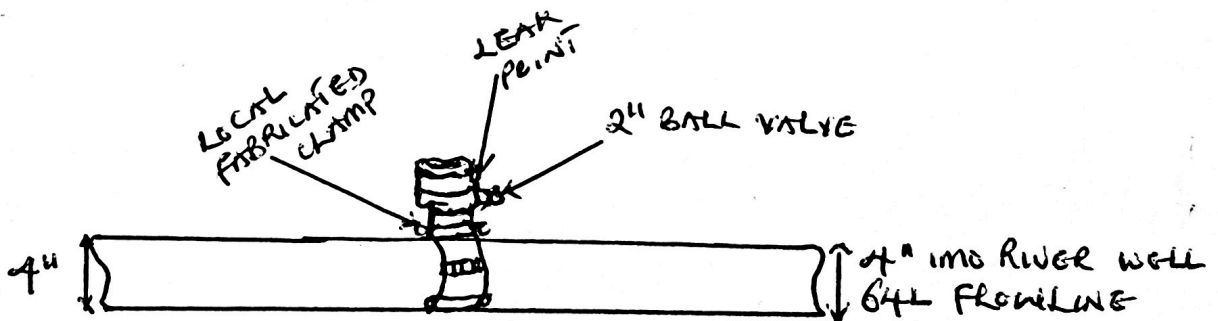
| <input checked="" type="checkbox"/> Crude oil theft (illegal bunkering) point, | <input type="checkbox"/> Saver-pit over flow | <input type="checkbox"/> Third party tampering with Clamp |

E. GRAPHIC DESCRIPTION OF LEAK POINT (while detail report of the leak point should be contained in the leak report, overview sketch of the site should be added as an appendix 1) A SECTION OF 4" IMC RIVER WELL 64L FLOWLINE AT IGIRUKHU (GUAZA) SHOWING A 2" BALL VALVE ATTACHED TO A LOCAL FABRICATED CLAMP AT 12 O'CLOCK POSITION BY UNKNOWN PERSONS.
