Overview: Part of spill impact on 20" Kolocreek-Rumuekpe Pipeline at Odau. Picture was taken during Joint Investigation of 31st December 2021.

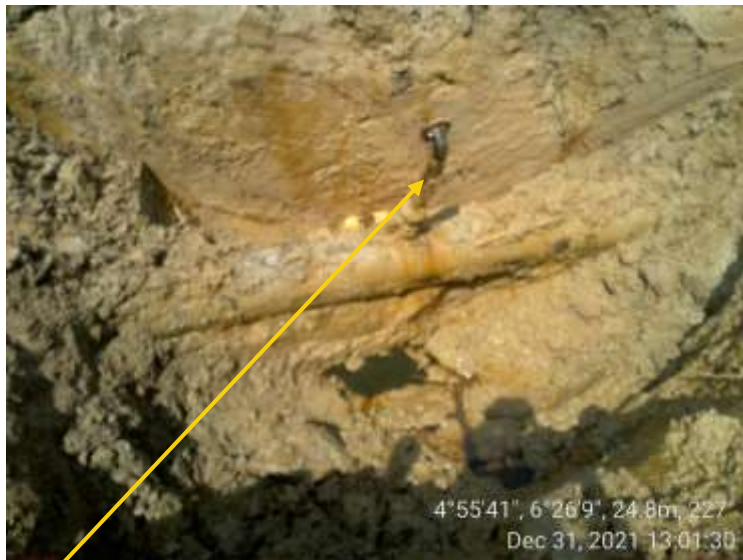
Close-up: 3inch ball valve with 3inch elbow connection installed at 12 o'clock position on 20" Kolocreek - Rumuekpe Pipeline at Odau. Picture was taken during Joint Investigation of 31st December 2021.
