JOINT INVESTIGATION REPORT

INCIDENT NO: 3077668 JIV report S/N: 01114

1. Fountain Incident Number: 3077668 2. Type of incident: OIL SPILL
 3. Name of location: 20" KORO CREEK-RUMUEKPE PIPELINE
 4. Name of nearest community: ODAU 5. State: RIVERS 6. LGA: ABUJA/ODUAL
 7. Production Facility/Installation: CRUDE OIL PIPELINE
 8. Asset Owner/Hub: THE SHELL PETROLEUM DEVELOPMENT COMPANY OF NIGERIA LIMITED (SPDC) PIPELINE

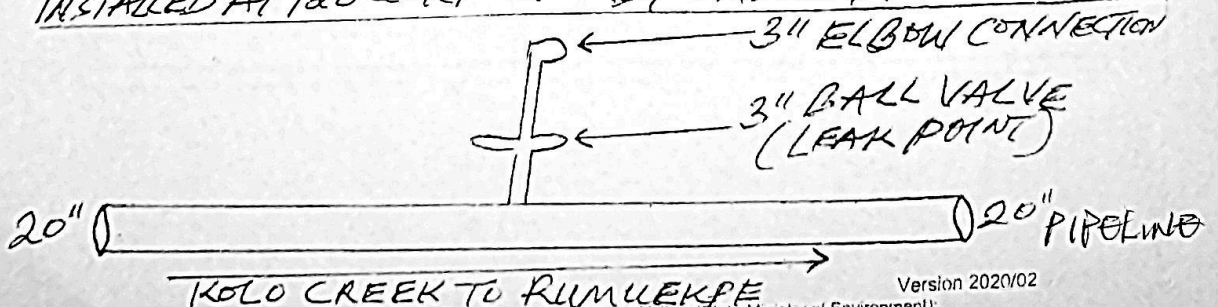
E. GRAPHIC DESCRIPTION OF LEAK POINT (while detail report of the leak point should be contained in the leak report, overview sketch of the site should be added as an appendix 1) A SECTION OF 20" KOLO

CREEK- RUMUEKPE PIPELINE AT ODAY (NEW LINE) SHOWING A 3" BALL VALVE WITH A 3" ELBOW CONNECTION INSTALLED AT 12 O'CLOCK POSITION BY UNKNOWN PERSON(S)

REPAIR BY CLAMPING
