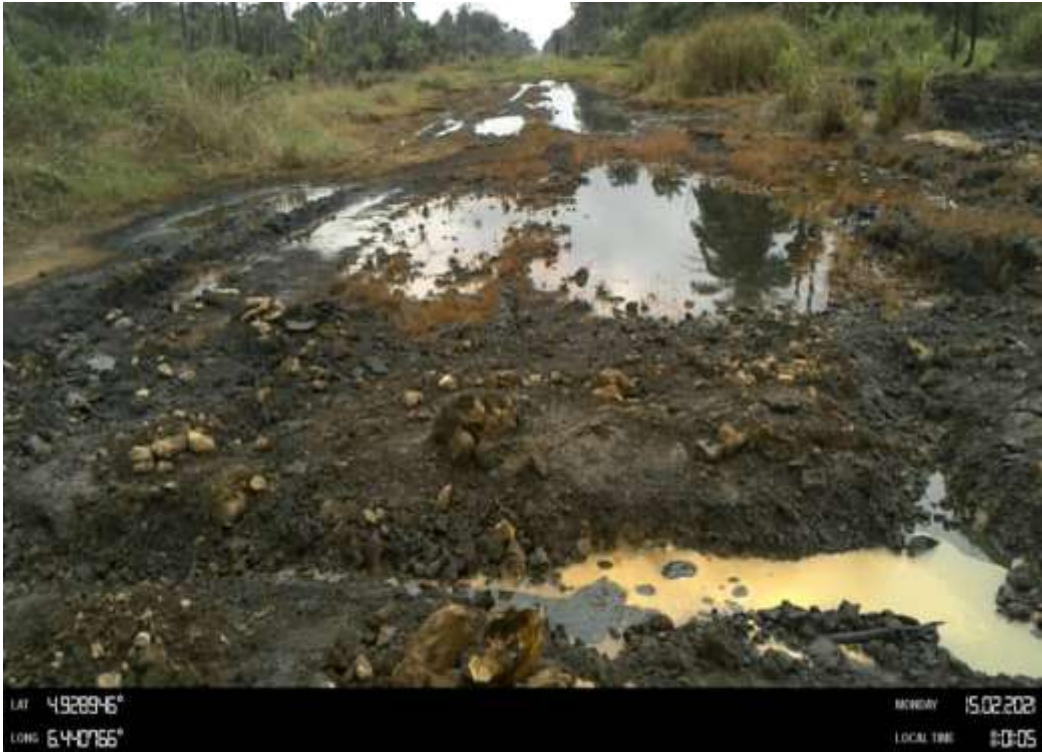
Overview: Part of spill impact on 20inch Kolocreek – Rumuekpe Pipeline at Odau Km9 .  
Picture was taken during Joint Investigation of 15<sup>th</sup> February 2021.

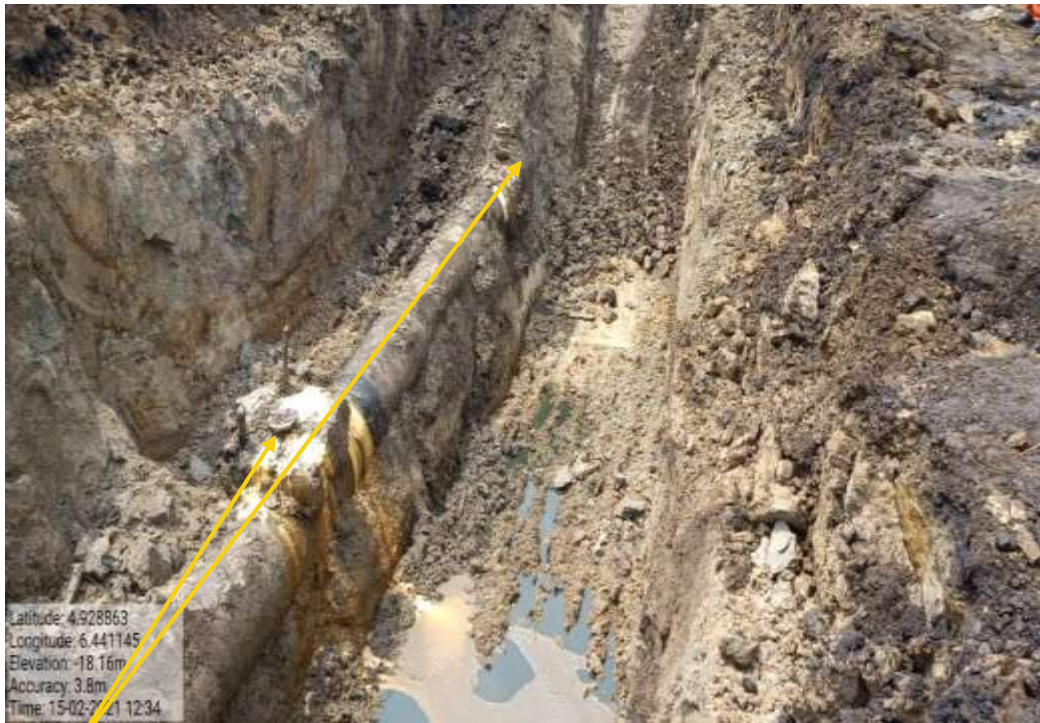
Close-up: 4inch valve with a concrete cast and a non-leaking 4inch valve of 5.2m apart installed at 12 o'clock position on 20inch Kolocreek – Rumuekpe Pipeline at Odau Km9 .  
Picture was taken during Joint Investigation of 15<sup>th</sup> February 2021.
