# JOINT INVESTIGATION REPORT

INCIDENT NO: 2859715 JIV report S/N: 0000753

1. Fountain Incident Number: 2859715 2. Type of incident\* OIL SPILL  
3. Name of Location 20<sup>m</sup> KOLOCREEK - RUMUEKPE PIPELINE  
4. Name of nearest community ODAU (km9) 5. State: RIVERS 6. LGA ABUA/ODUAL  
7. Production Facility/Installation OIL PIPELINE  
8. Asset Owner/Hub THE SHELL PETROLEUM DEVELOPMENT COMPANY OF NIGERIA LIMITED (SPDC)/PIPELINE

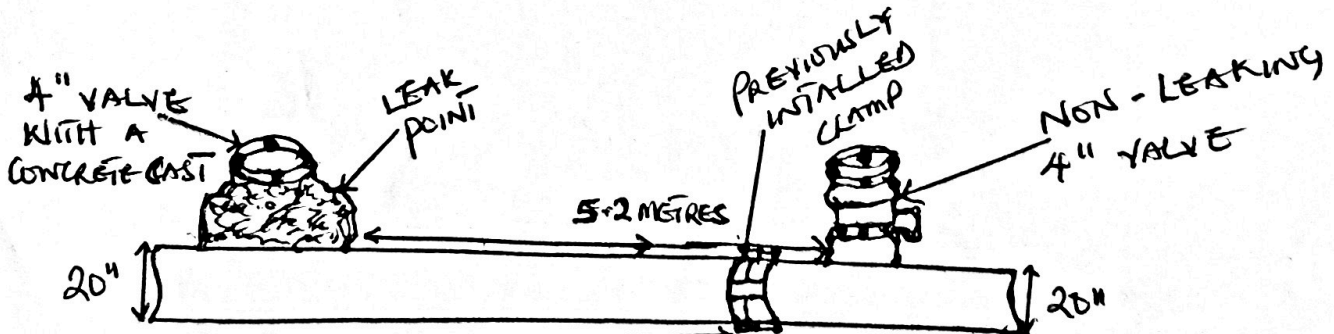
**E. GRAPHIC DESCRIPTION OF LEAK POINT** (while detailed description of the leak point should be contained in the leak report, overview sketch of the site should be added as appendix 1)

Additional observations around the spill point: THE JOINT INVESTIGATION TEAM OBSERVED A PREVIOUSLY INSTALLED CLAMP.

| <input checked="" type="checkbox"/> Crude oil theft (illegal bunkering) point, | <input type="checkbox"/> Saver-pit over flow | <input type="checkbox"/> Third party tampering with Clamp |

A SECTION OF 20" KOLOCREEK-RUMUEKPE PIPELINE AT ODAU (km 9) SHOWING A 4" VALVE WITH A CONCRETE CAST AND A NON-LEAKING 4" VALVE OF 5.2 METRES APART INSTALLED AT 12 O'CLOCK POSITION BY UNKNOWN PERSONS ALONGSIDE A PREVIOUSLY INSTALLED CLAMP.

CRUDE OIL RECOVERY AND REPAIR ACTIVITIES ONGOING
