Overview: Part of spill impact on 14inch Okordia Rumuekpe Pipeline at Akinima . Picture was taken during Joint Investigation of 18th February 2021.

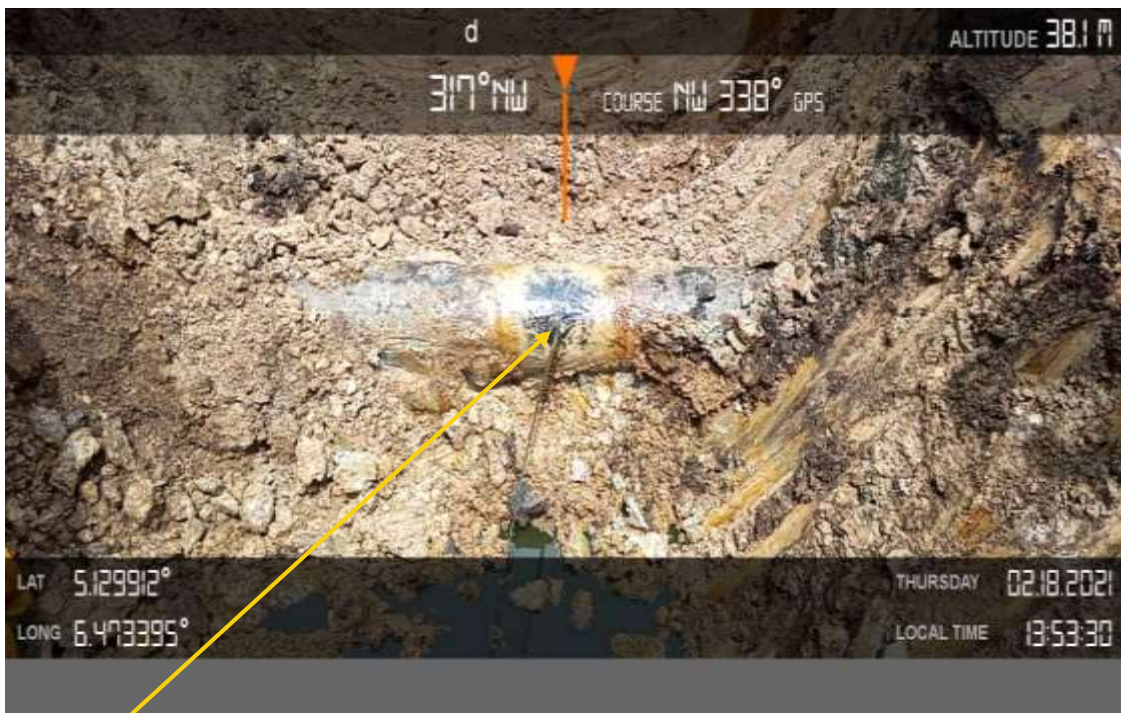
Close-up: Hacksaw cut at 2 o'clock position on 14inch Okordia Rumuekpe Pipeline at Akinima . Picture was taken during Joint Investigation of 18th February 2021.
