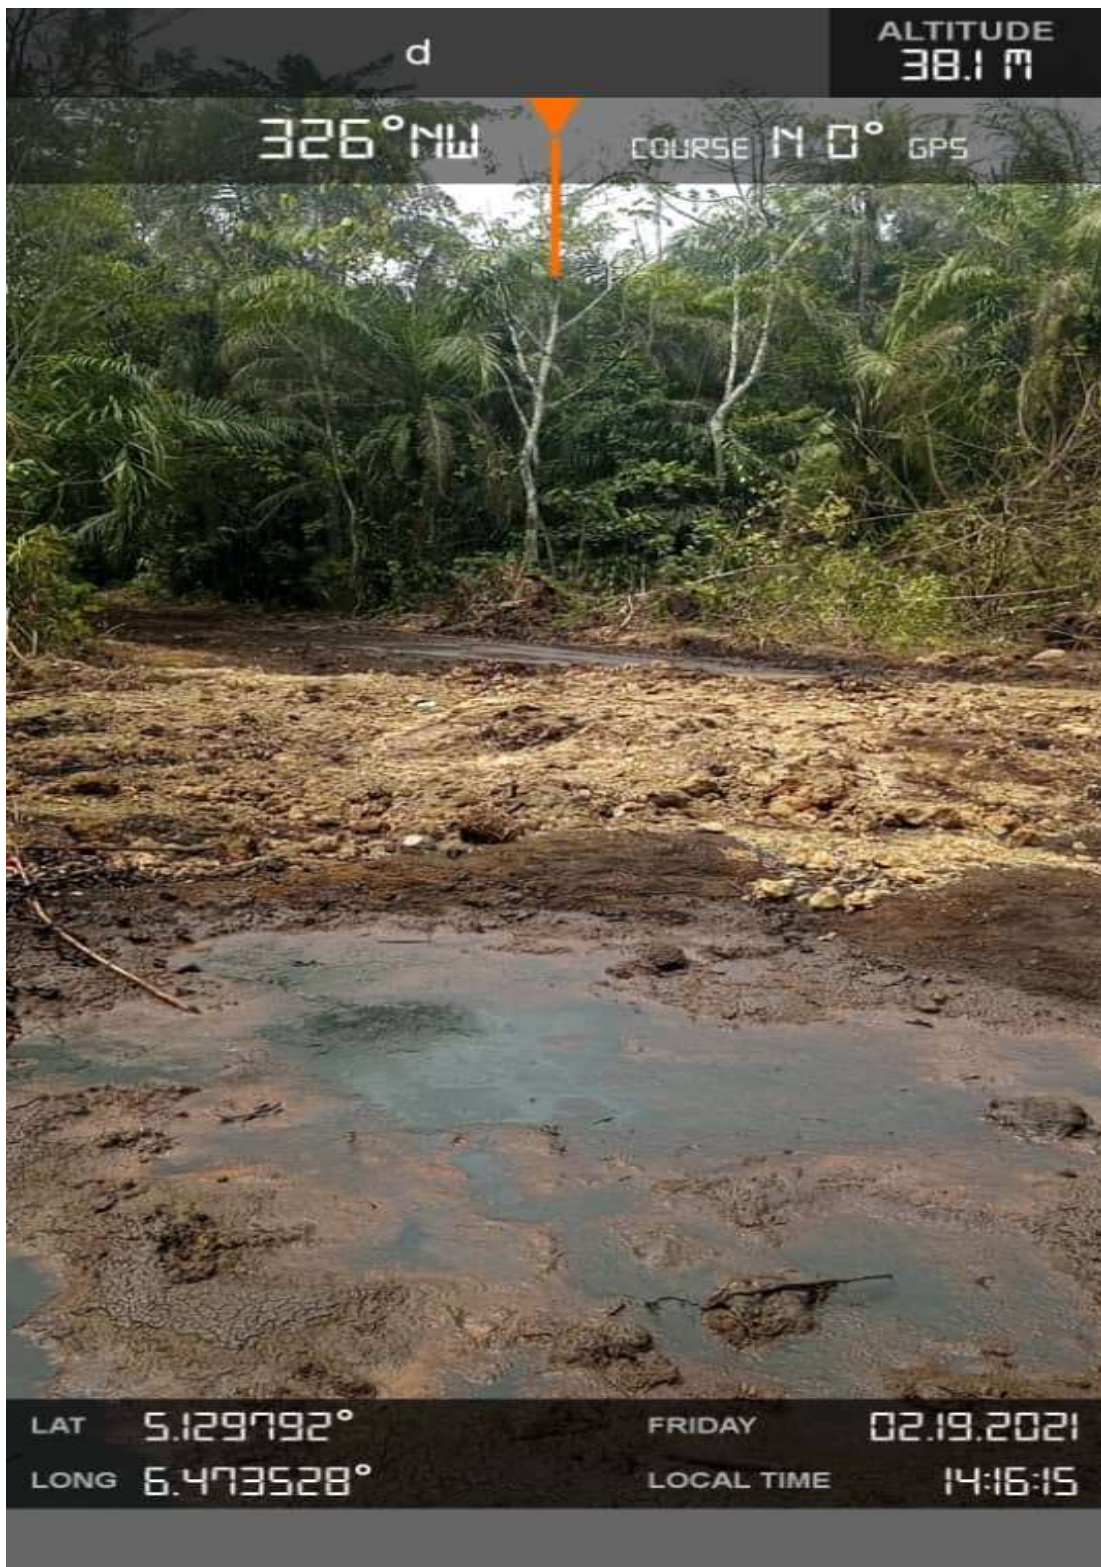
Overview: Part of spill impact on 14inch Okordia Rumuekpe Pipeline at Ikarama .
Picture was taken during Joint Investigation of 19th Feb 2021.

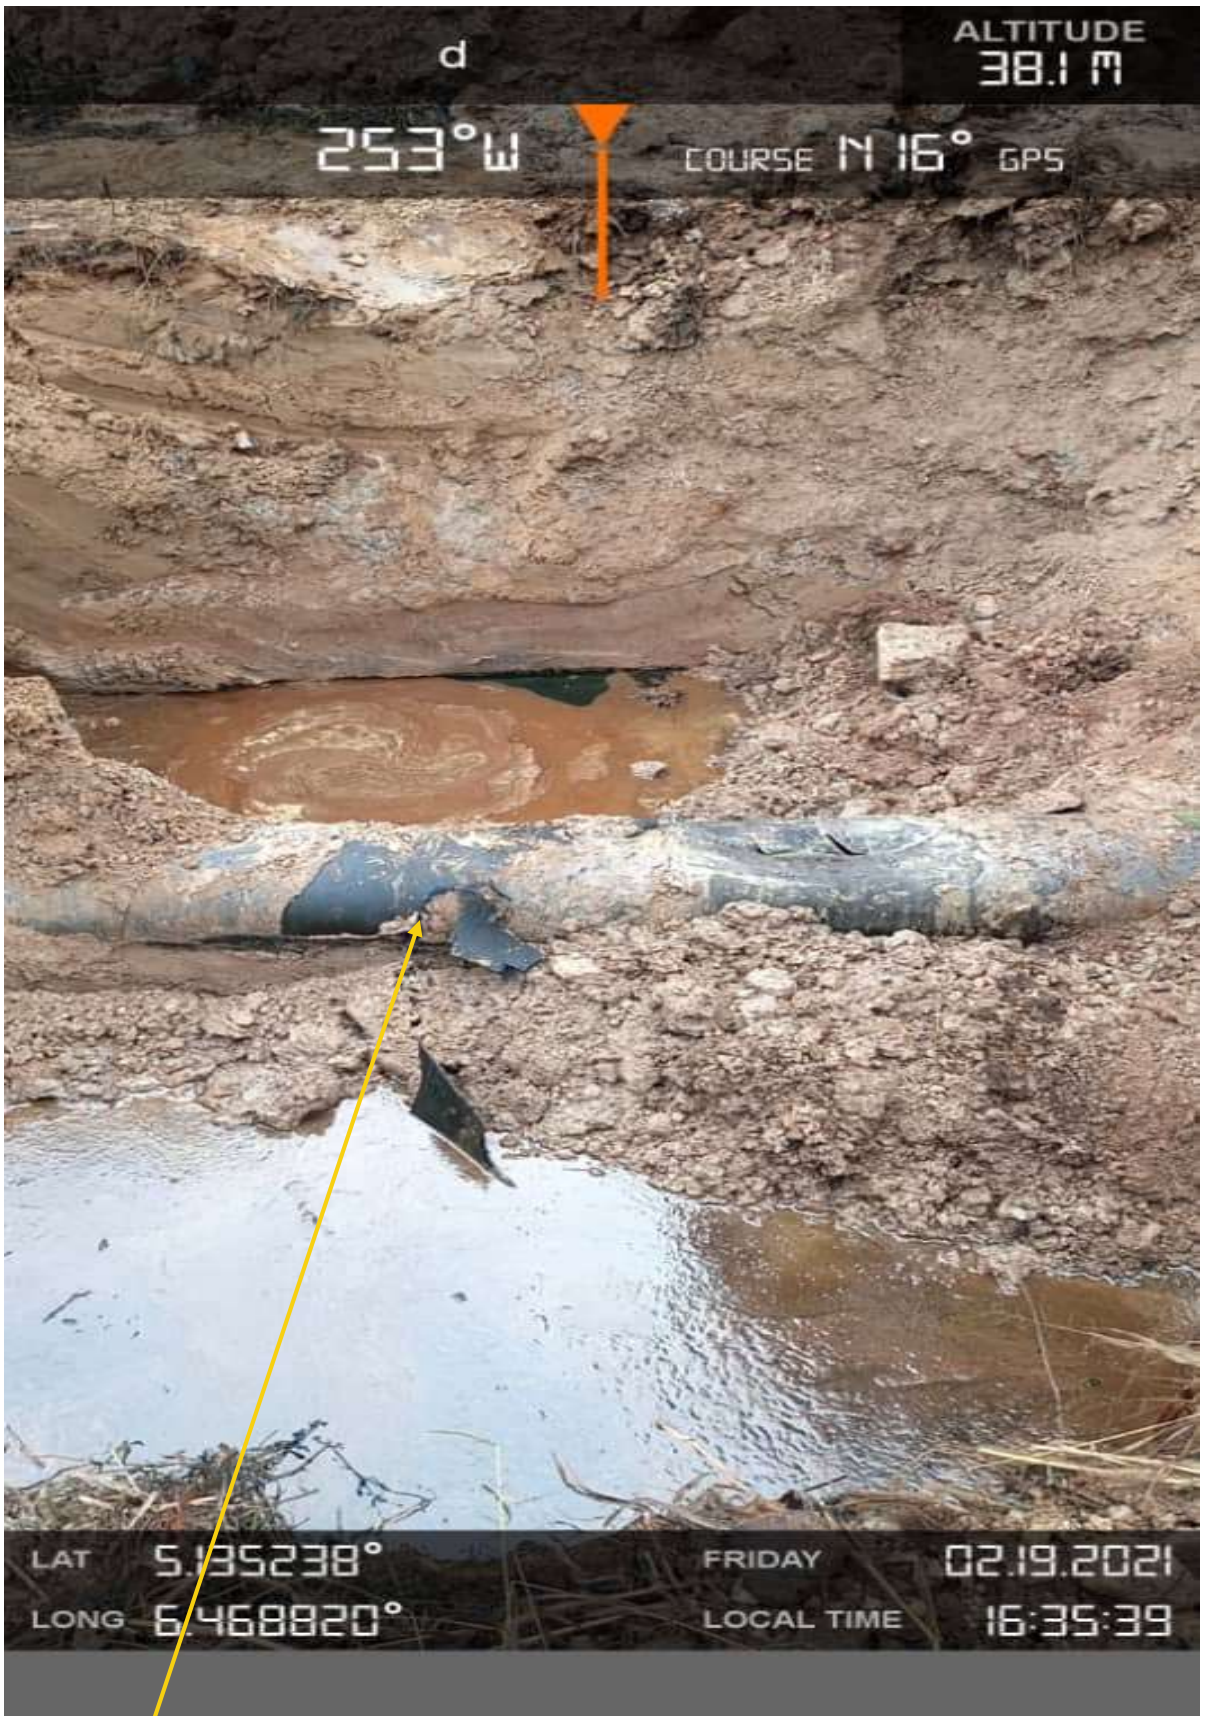
Close-up 1: A Tear at Point 1 (6 o'clock position) on 14inch Okordia Rumuekpe Pipeline at Ikarama . Picture was taken during Joint Investigation of 19th Feb 2021.

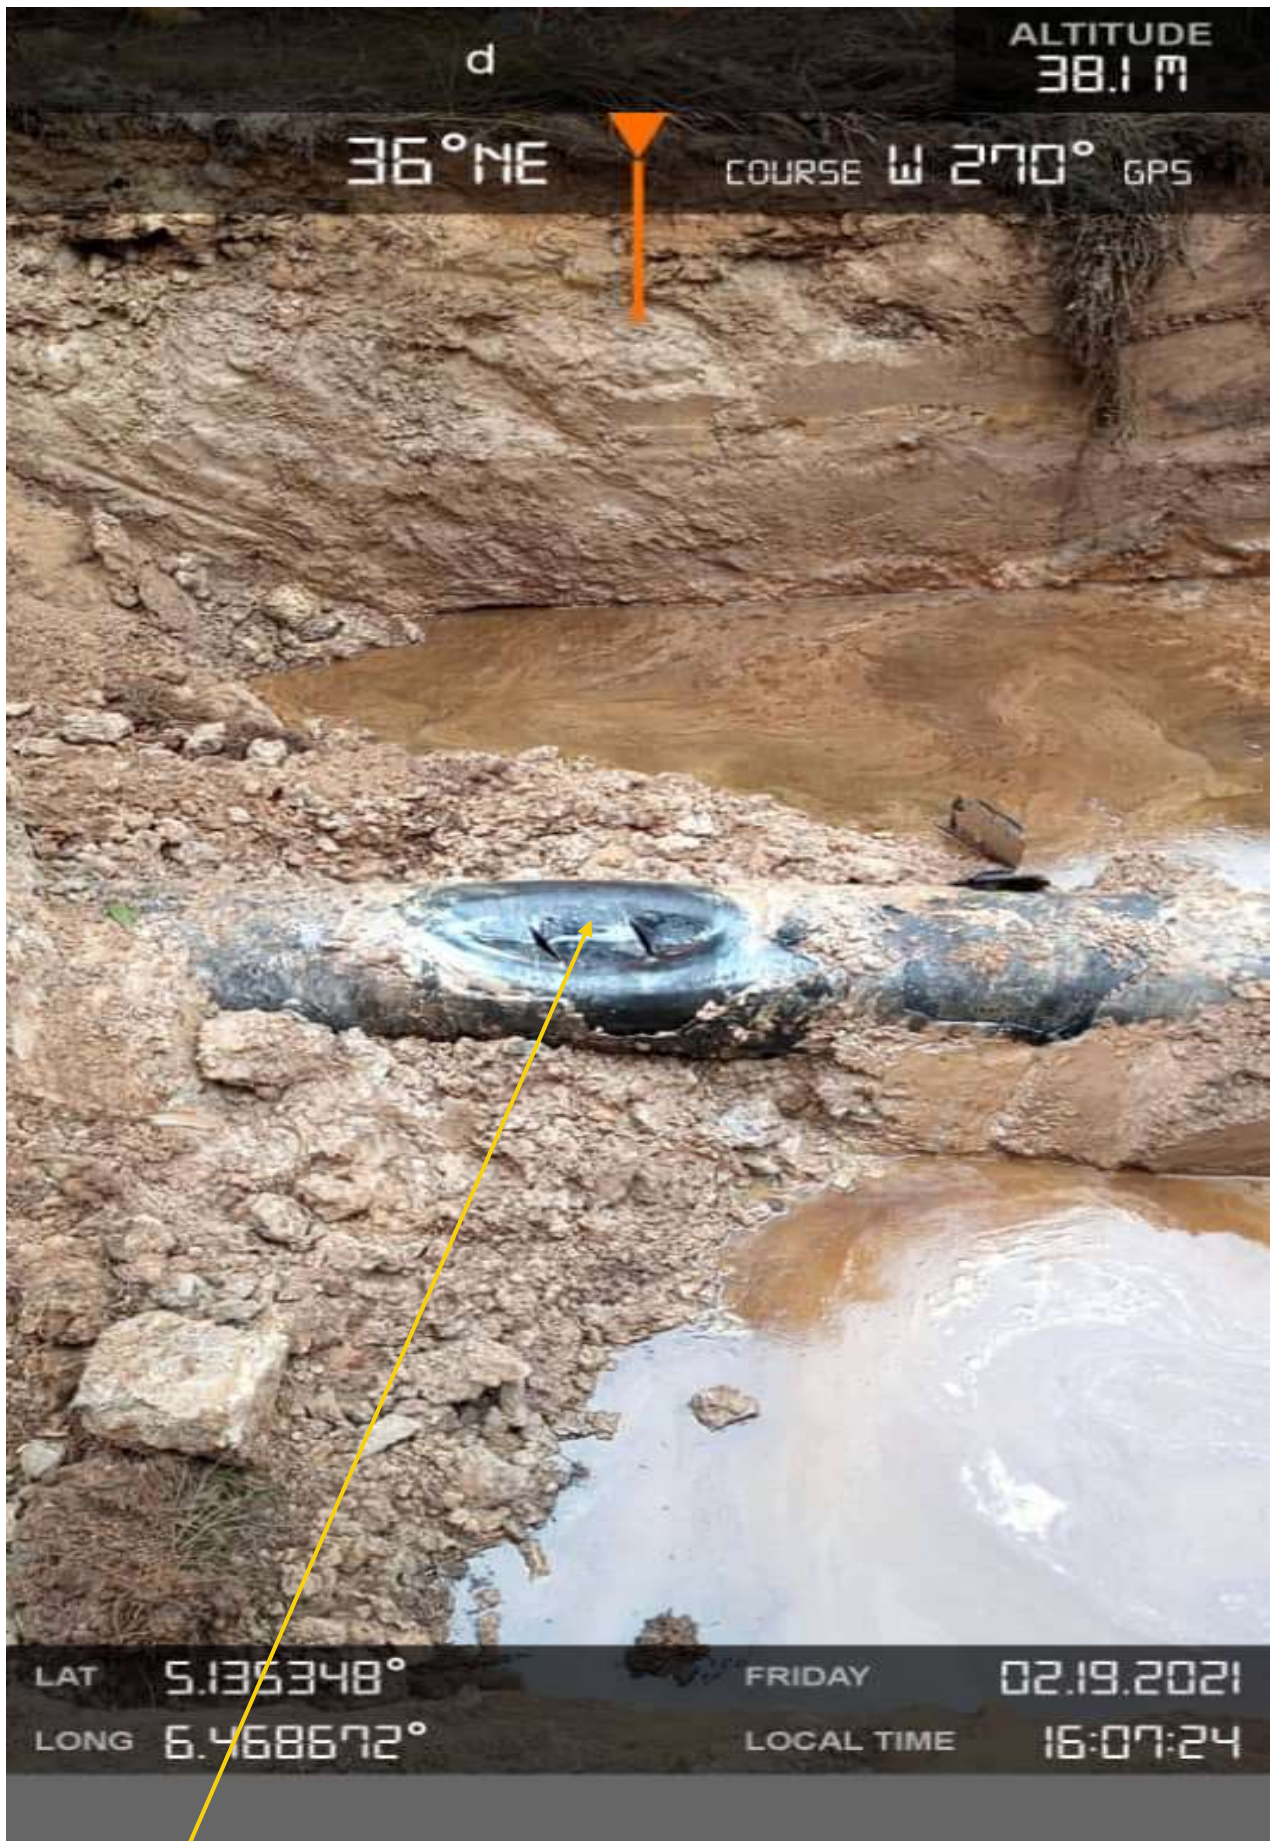
Close-up 2: Inward dent/double cut at point 2 (12 o'clock position) on 14inch Okordia Rumuekpe Pipeline at Ikarama . Picture was taken during Joint Investigation of 19th Feb 2021 .

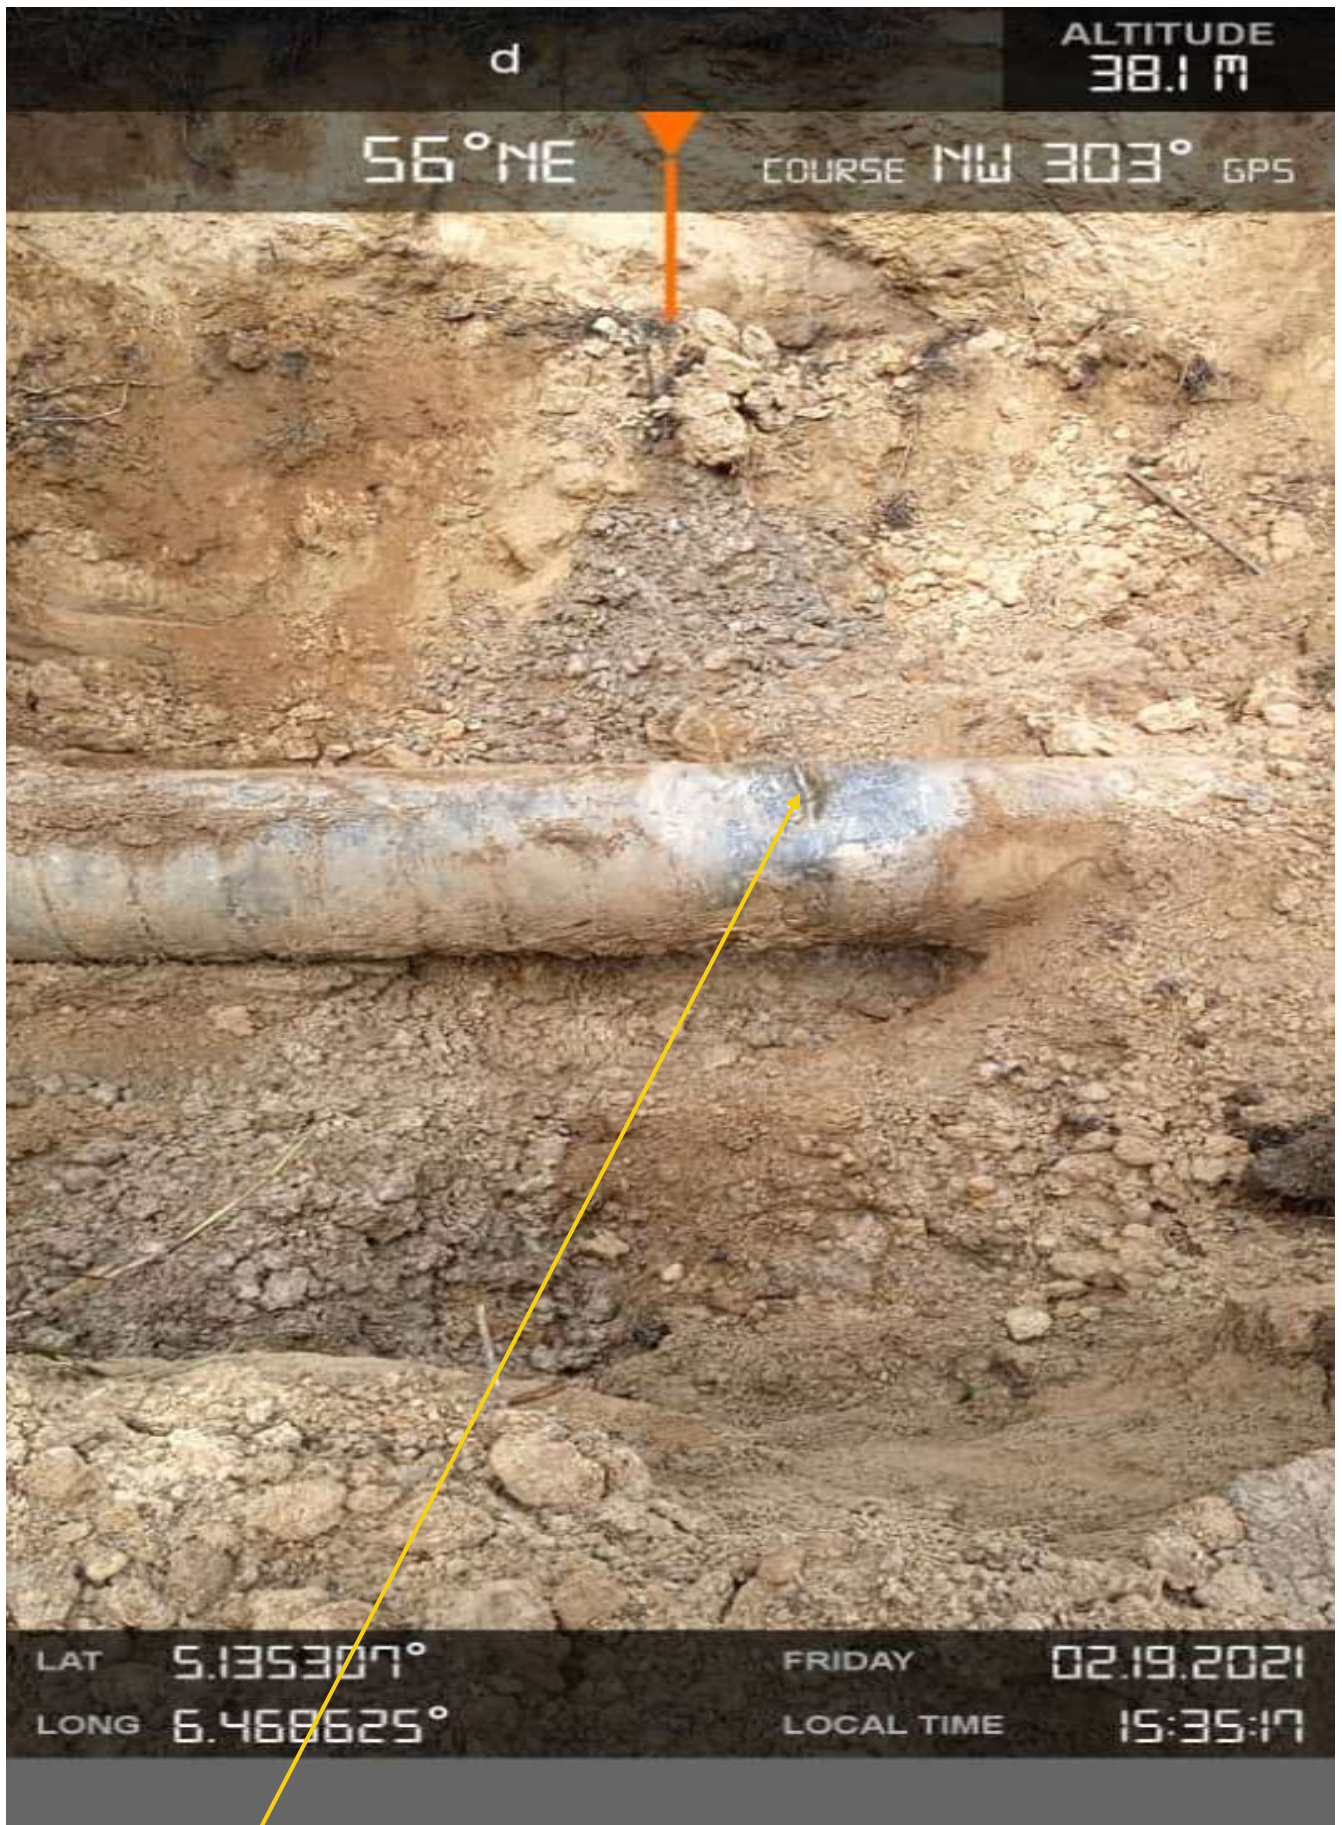
Close-up 3: Chisel impact with no cut through at point 3 (12 o'clock position) on 14inch Okordia Rumuekpe Pipeline at Ikarama . Picture was taken during Joint Investigation of 19th Feb 2021 .
