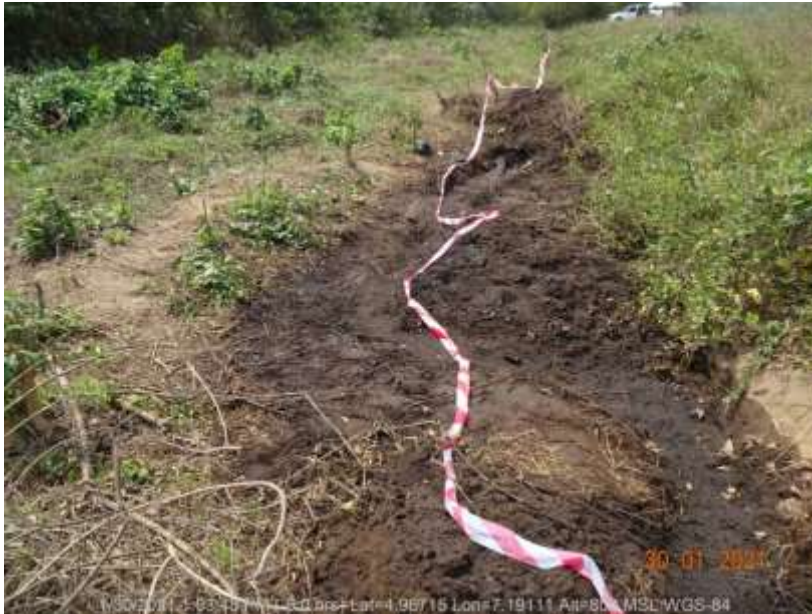
Overview: Part of spill impact on 4inch ImoRiver 2-1-testline at Igiriukwu . Picture was taken during Joint Investigation of 30th January 2021.

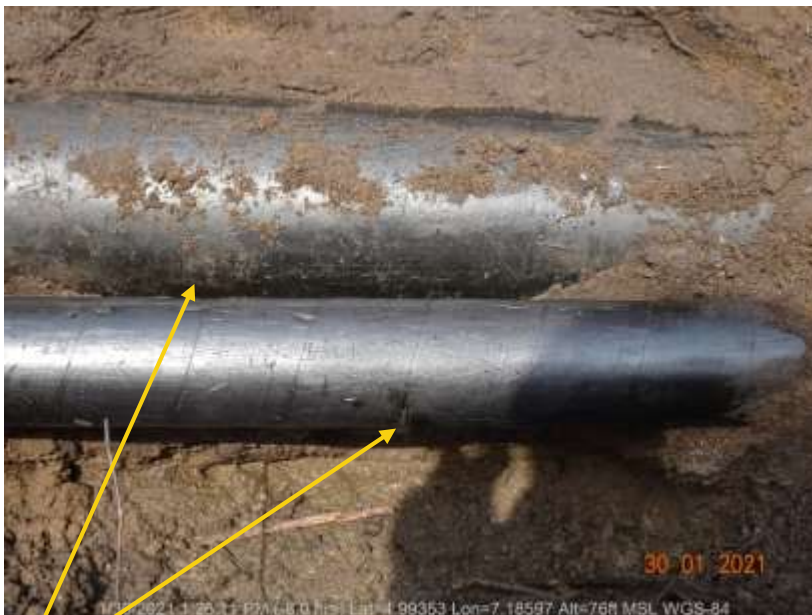
Close-up: Hacksaw cut from 10 - 7 o'clock position and 10 - 8 o'clock position respectively on 4inch ImoRiver 2-1-testline at Igiriukwu . Picture was taken during Joint Investigation of 30th January 2021.
