# JOINT INVESTIGATION REPORT

INCIDENT NO: 2832536 JIV report S/N: 0745

1. Fountain Incident Number: 2832536 2. Type of incident\* OIL SPILL  
3. Name of Location 12" OGUTA-EEBEMA PIPELINE  
4. Name of nearest community OPUOMA 5. State: IMO 6. LGA OHATI-EEBEMA  
7. Production Facility/Installation CRUDE OIL PIPELINE  
8. Asset Owner/Hub THE SHELL PETROLEUM DEVELOPMENT COMPANY  
OF NIGERIA LIMITED / PIPELINE

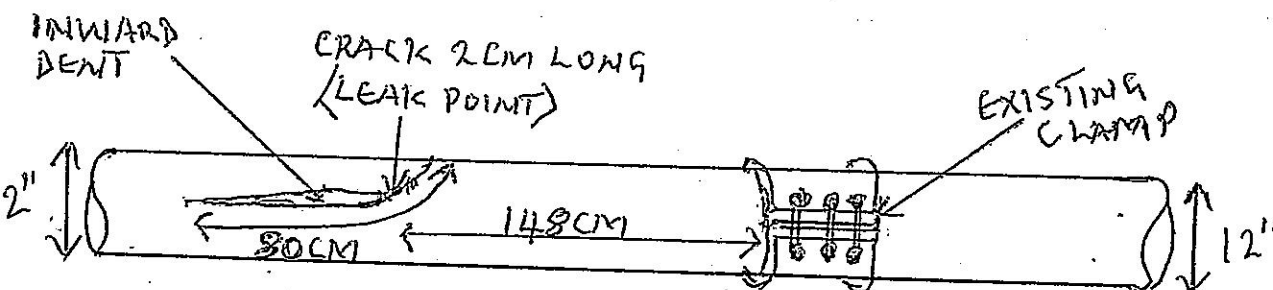
SECTION 1 OF 12" OGITA-EGBENIA PIPELINE AT OPUOMA  
SHOWING INWARD DENT AND CRACK AT 1 O'CLOCK POSITION.

FROM OGITA TO EGBENIA

<input type="checkbox"/> Smooth round-edge hole	<input type="checkbox"/> Rough-edge hole	<input type="checkbox"/> Hack saw cut
<input type="checkbox"/> Complete Rupture	<input checked="" type="checkbox"/> Inward dent,	<input type="checkbox"/> Well head tampering
<input type="checkbox"/> Failed Weld-on illegal hot tap valve	<input type="checkbox"/> Failed Clamp,	<input type="checkbox"/> Missing Pipeline/Flowline
<input type="checkbox"/> Crude oil theft (illegal bunkering) point,	<input type="checkbox"/> Saver-pit over flow	<input type="checkbox"/> Third party tampering with Clamp
<input type="checkbox"/> Third party tampering with valve setting	<input type="checkbox"/> Bulging Outward	<input type="checkbox"/> Third party tampering with flange,
<input type="checkbox"/> Flare System/Bund wall failure	<input type="checkbox"/> Cold vent	<input type="checkbox"/> Surge vessel overflow,
<input type="checkbox"/> Valve Failure	<input type="checkbox"/> Relief valve failure	<input checked="" type="checkbox"/> Accidental 3 <sup>rd</sup> party equipment impact

☒ Third party interference (Sabotage ☐; crude theft ☐; Line theft ☐; Accidental 3<sup>rd</sup> party damage ☒  
☐ Operational ☐ Others (including Mystery spills) \_\_\_\_\_
