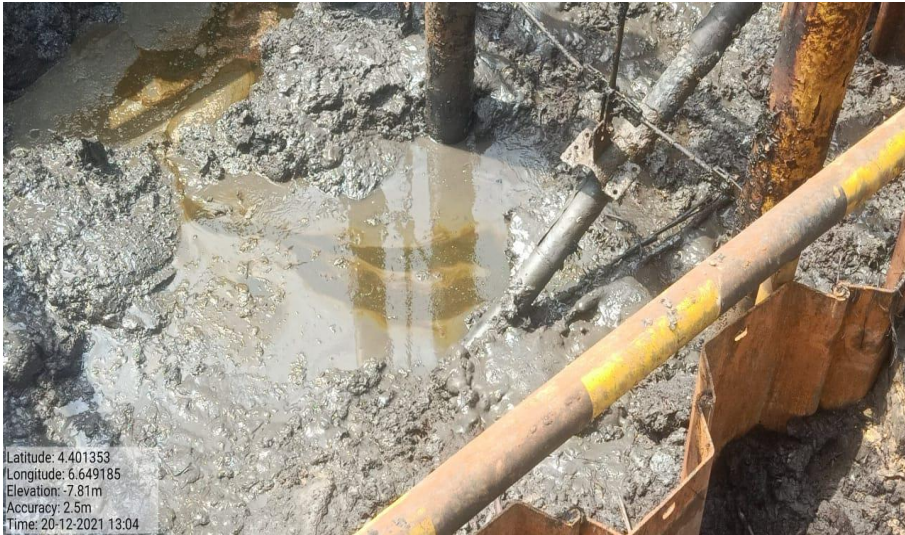
Overview: Part of spill impact on 6'' Belema Delivery line Right of Way at Belema. Picture was taken during Joint Investigation of 20th December 2021.

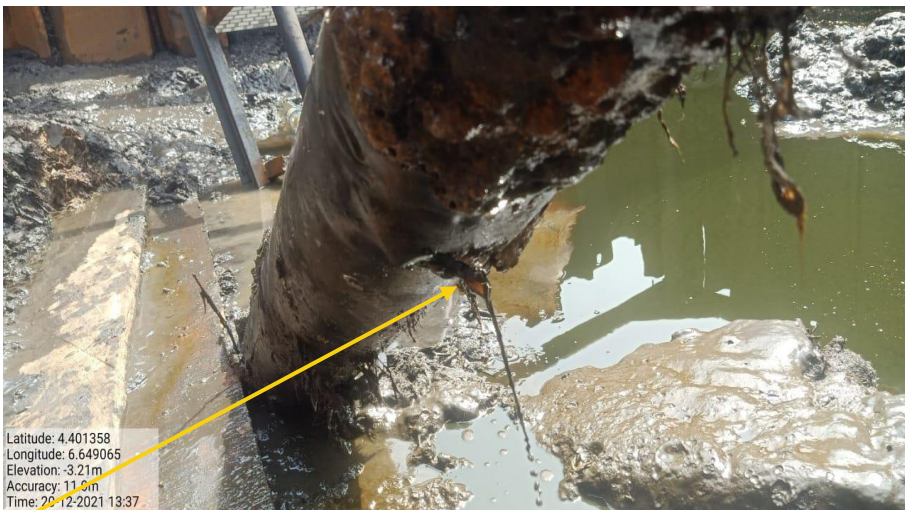
Close-up: 20mm Rough-edge Hole due to corrosion at 6 o'clock position on 6'' Belema Delivery line at Belema. . Picture was taken during Joint Investigation of 20th December 2021.
