JOINT INVESTIGATION REPORT

INCIDENT NO: 2988284 JIV report S/N: 0000793

1. Fountain Incident Number: 2988284 2. Type of incident* OIL SPILL
3. Name of Location 14" OKORDIA - RUMUEKPE PIPELINE
4. Name of nearest community IHUOWO 5. State: RIVERS 6. LGA AHOADA-EAST
7. Production Facility/Installation OIL PIPELINE
8. Asset Owner/Hub THE SHELL PETROLEUM DEVELOPMENT COMPANY OF NIGERIA LIMITED (SPDC) / PIPELINE

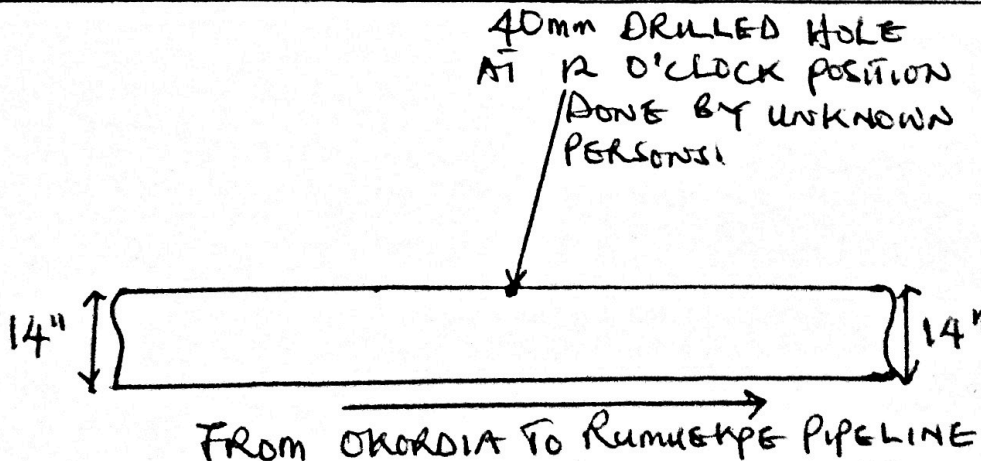
E. GRAPHIC DESCRIPTION OF LEAK POINT (while detailed description of the leak point should be contained in the leak report, overview sketch of the site should be added as appendix 1)

A SECTION OF 14" OKORDIA - RUMUEKPE PIPELINE AT IHUONO SHOWING A 40mm DRILLED HOLE AT 12 O'CLOCK POSITION DONE BY UNKNOWN PERSONS.
