JOINT INVESTIGATION REPORT

INCIDENT NO: 2993510 JIV report S/N: 0000908

1. Fountain Incident Number: 2993510 2. Type of incident* OIL SPILL & FIRE
3. Name of Location 14" OKORDIA-RUMIEKPE PIPELINE
4. Name of nearest community IHYONO 5. State: RIVERS 6. LGA AHOADA EAST
7. Production Facility/Installation PIPELINE
8. Asset Owner/Hub THE SHELL PETROLEUM DEVELOPMENT COMPANY OF NIGERIA LIMITED (SPDC)/PIPELINE

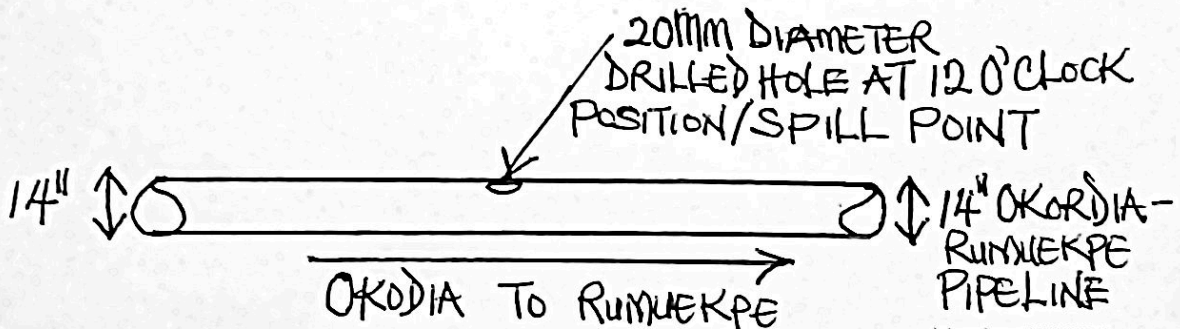
E. GRAPHIC DESCRIPTION OF LEAK POINT (while detailed description of the leak point should be contained in the leak report, overview sketch of the site should be added as appendix 1)

A SECTION OF 14" OKODIA-RUMUEKPE PIPELINE AT ITHUWO SHOWING A 20MM DIAMETER DRILLED HOLE AT 12 O'CLOCK POSITION BY UNKNOWN PERSON(S).

REPAIR BY CLAMPING
