JOINT INVESTIGATION REPORT

INCIDENT NO: 2993589 JIV report S/N: 0000909

1. Fountain Incident Number: 2993589 2. Type of incident* OIL SPILL
3. Name of Location NUN RIVER 3" WELL 13T FLOWLINE
4. Name of nearest community OPOROMA 5. State: BAYELSA 6. LGA SOUTHERN IJAW
7. Production Facility/Installation FLOWLINE
8. Asset Owner/Hub THE SHELL PETROLEUM DEVELOPMENT COMPANY OF NIGERIA LIMITED (SPDC) EAST HUB

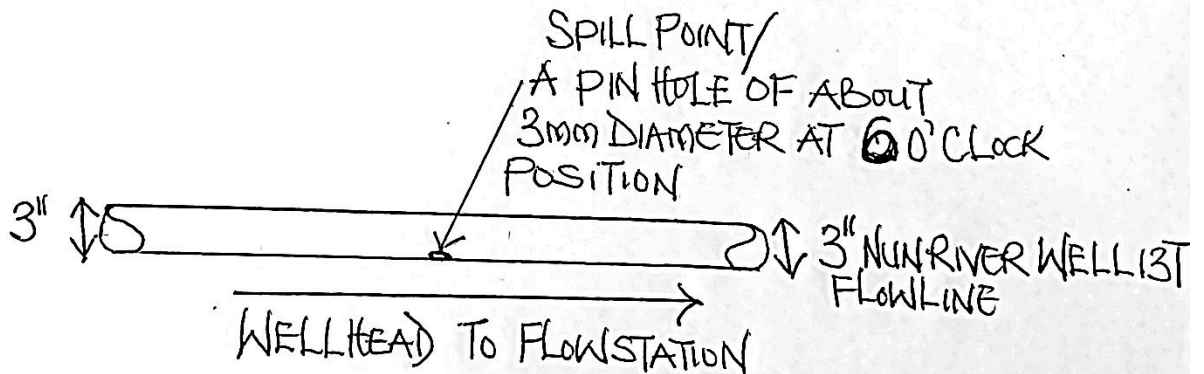
E. GRAPHIC DESCRIPTION OF LEAK POINT *(while detailed description of the leak point should be contained in the leak report, overview sketch of the site should be added as appendix 1)*

A SECTION OF 3" NUN RIVER WELL 13T FLOWLINE AT OPOROMA SHOWING A ROUGH-EDGE HOLE OF ABOUT 3mm DIAMETER AT 6 O' CLOCK POSITION INDICATING SIGN OF CORROSION.
