# JOINT INVESTIGATION REPORT

INCIDENT NO: 2995348 JIV report S/N: 0000910

1. Fountain Incident Number: 2995348 2. Type of incident\* OIL SPILL  
3. Name of Location 14<sup>th</sup> OKORDIA - RUMUEKPE PIPELINE AT AKALA-OLU  
4. Name of nearest community AKALA-OLU 5. State: RIVERS 6. LGA AHOADA WEST  
7. Production Facility/Installation PIPELINE  
8. Asset Owner/Hub THE SHELL PETROLEUM DEVELOPMENT COMPANY OF NIGERIA LIMITED (SPDC)/PIPELINE

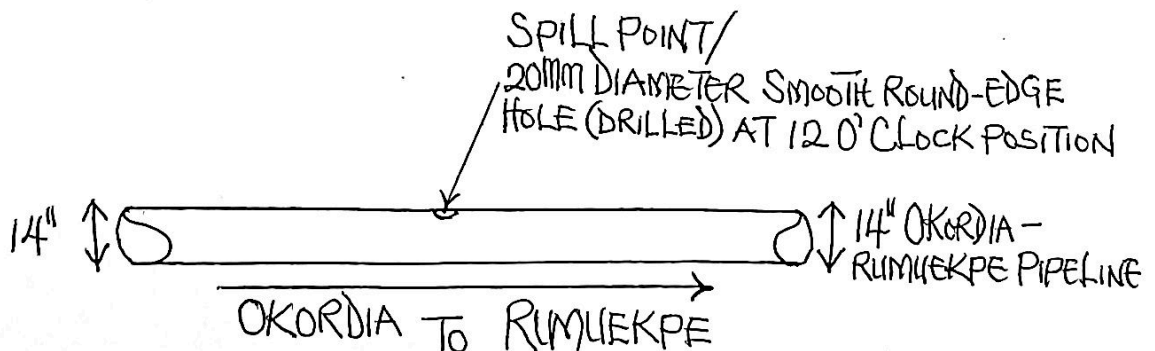
| <input checked="" type="checkbox"/> Smooth round-edge hole | <input type="checkbox"/> Rough-edge hole | <input type="checkbox"/> Hack saw cut |

**E. GRAPHIC DESCRIPTION OF LEAK POINT** (while detailed description of the leak point should be contained in the leak report, overview sketch of the site should be added as appendix 1) A SECTION OF 14" OKORDIA-RUMUEKPE PIPELINE AT AKALA-OLU SHOWING 20mm DIAMETER DRILLED HOLE AT 12 O'CLOCK POSITION BY UNKNOWN PERSON(S).

REPAIR BY CLAMPING
