JOINT INVESTIGATION REPORT

INCIDENT NO: 2999627 JIV report S/N: 0000946

1. Fountain Incident Number: 2999627 2. Type of incident: OIL SPILL
3. Name of Location: 20" KORO CREEK - RUMUEKPE TRUNKLINE
4. Name of nearest community: IHUONO 5. State: RIVERS 6. LGA: AHIAZA EAST
7. Production Facility/Installation: OIL PIPELINE
8. Asset Owner/Hub: THE SHELL PETROLEUM DEVELOPMENT COMPANY

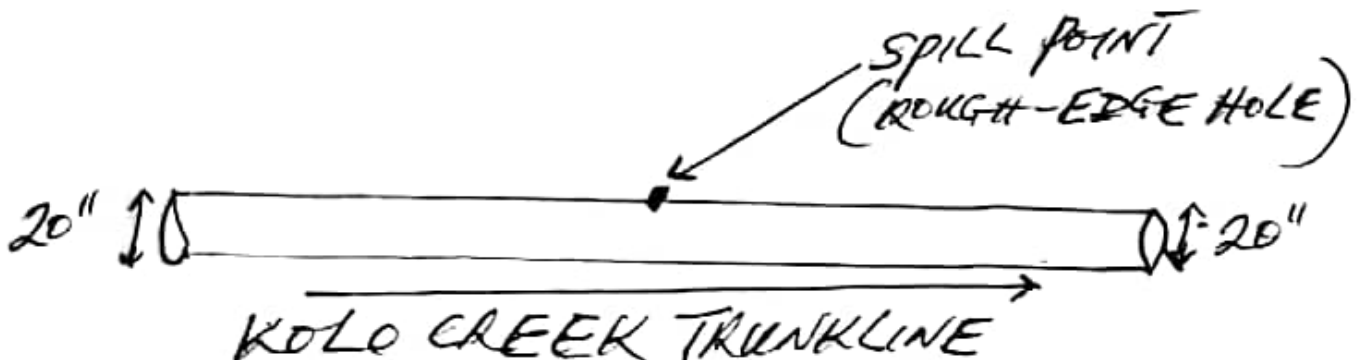
E. GRAPHIC DESCRIPTION OF LEAK POINT (while detailed description of the leak point should be contained in the leak report, overview sketch of the site should be added as appendix 1)

A SECTION OF 20" KOLO CREEK - RUMUEKPE TRUNKLINE AT HUMAN STAFF WORK ROUGH-EDGE HOLE AT 12 O'CLOCK POSITION BY UNKNOWN PERSON(S)

REPAIR BY CLAMPING
