JOINT INVESTIGATION REPORT

INCIDENT NO: 2999592 JIV report S/N: 0000947

1. Fountain Incident Number: 2999592 2. Type of incident* OIL SPILL
3. Name of Location 20" KOLO CREEK - RUMUEKPE TRUNKLINE
4. Name of nearest community OKPOROWO, State: RIVERS 6. LGA AHOADA EAST
7. Production Facility/Installation OIL PIPELINE
8. Asset Owner/Hub THE SHELL PETROLEUM DEVELOPMENT COMPANY

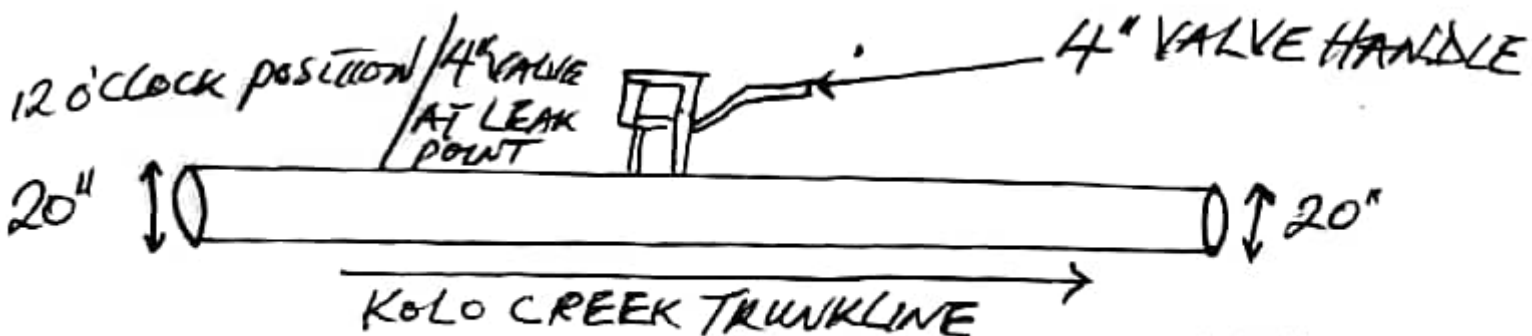
E. GRAPHIC DESCRIPTION OF LEAK POINT (while detailed description of the leak point should be contained in the leak report, overview sketch of the site should be added as appendix 1)

| <input checked="" type="checkbox"/> Crude oil theft (illegal bunkering) point, | <input type="checkbox"/> Saver-pit over flow | <input type="checkbox"/> Third party tampering with Clamp |

A SECTION OF 20" KOLO CREEK - RUMUEKPE TRUNKLINE AT OKPORO'S SHOWING 4" VALVE INSTALLED AT 12 O'CLOCK POSITION BY UNKNOWN PERSONS

REPAIR BY BLIND FLANGE
