# JOINT INVESTIGATION REPORT

INCIDENT NO: 2966432 JIV report S/N:

1. Fountain Incident Number: 2966432 2. Type of incident\* OIL SPILL  
3. Name of Location 24<sup>th</sup> BOMU - BONNY TRANS NIGER PIPELINE  
4. Name of nearest community OWOKIRI 5. State: RIVERS 6. LGA ANDONI  
7. Production Facility/Installation OIL PIPELINE  
8. Asset Owner/Hub THE SHELL PETROLEUM DEVELOPMENT COMPANY OF NIGERIA LIMITED PIPELINE

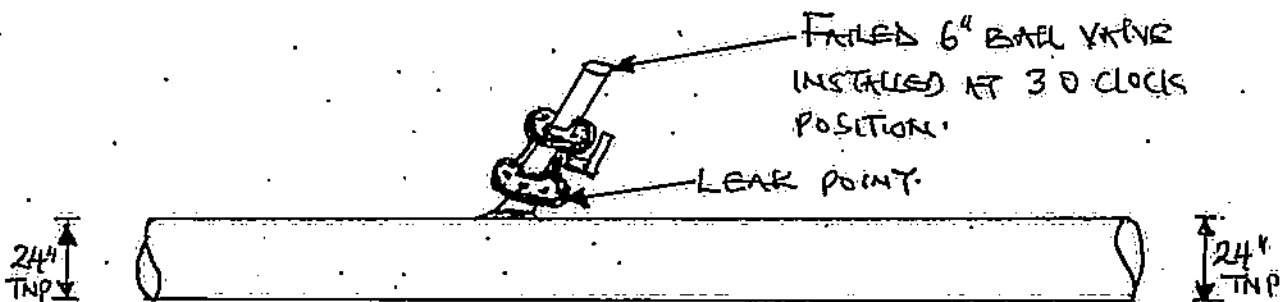
E. GRAPHIC DESCRIPTION OF LEAK POINT (while detailed description of the leak point should be contained in the leak report, overview sketch of the site should be added as appendix 1)

| <input checked="" type="checkbox"/> Failed Weld-on illegal hot tap valve | <input type="checkbox"/> Failed Clamp, | <input type="checkbox"/> Missing Pipeline/Flowline |
| <input checked="" type="checkbox"/> Crude oil theft (illegal bunkering) point, | <input type="checkbox"/> Saver-pit over flow | <input type="checkbox"/> Third party tampering with Clamp |

SECTIONAL VIEW OF 24" BOMU-BONNY TRANS NIGER PIPELINE AT OMWOKARI  
SHOWING:- A 6" BALL VALVE FLANGE LEAKING AT THE NIPPLE FLANGE INSTALLED  
AT 3 O CLOCK POSITION

RECOVERY AND REPAIR WORK ON GOING
