JOINT INVESTIGATION REPORT

INCIDENT NO: 2967280 JIV report S/N: 0000874

1. Fountain Incident Number: 2967280 2. Type of incident* OIL SPILL
3. Name of Location 4" MINNANTA WELL RT FLOWLINE
ELELE ALIMINI 4. Name of nearest community RIVERS 5. State: RIVERS 6. LGA EMOHUA
7. Production Facility/Installation CRUDE OIL FLOWLINE
8. Asset Owner/Hub THE SHELL PETROLEUM DEVELOPMENT COMPANY OF NIGERIA LIMITED / LAND EAST HUB.

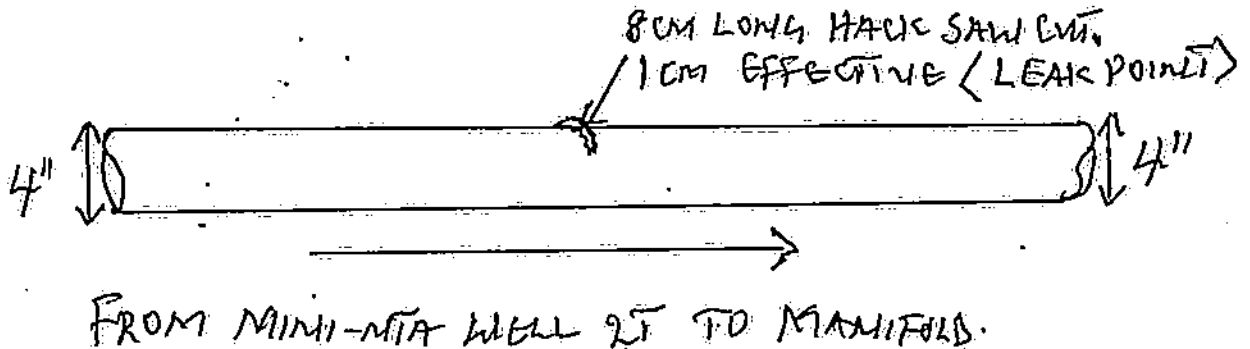
E. GRAPHIC DESCRIPTION OF LEAK POINT (while detailed description of the leak point should be contained in the leak report, overview sketch of the site should be added as appendix 1)

| <input type="checkbox"/> Smooth round-edge hole | <input type="checkbox"/> Rough-edge hole | <input checked="" type="checkbox"/> Hack saw cut |

SECTION OF 4" MINI-NIA WELL 2T FLOWLINE AT BLELE ALIMINI SHOWING HACK SAW CUT AT 11-12 O' CLOCK POSITION.

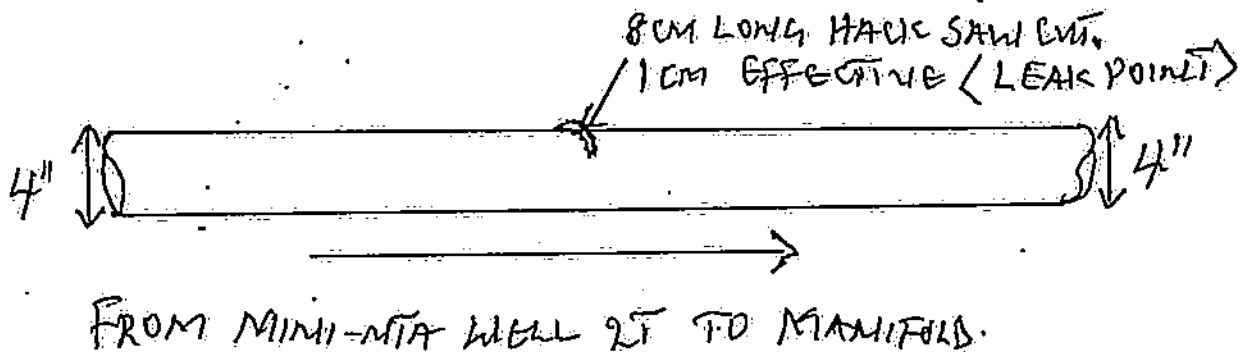
E. GRAPHIC DESCRIPTION OF LEAK POINT (while detailed description of the leak point should be contained in the leak report, overview sketch of the site should be added as appendix 1)

SECTION OF 4" MINI-NIA WELL 2T FLOWLINE AT BLELE ALIMINI SHOWING HACK SAW CUT AT 11-12 O' CLOCK POSITION.
