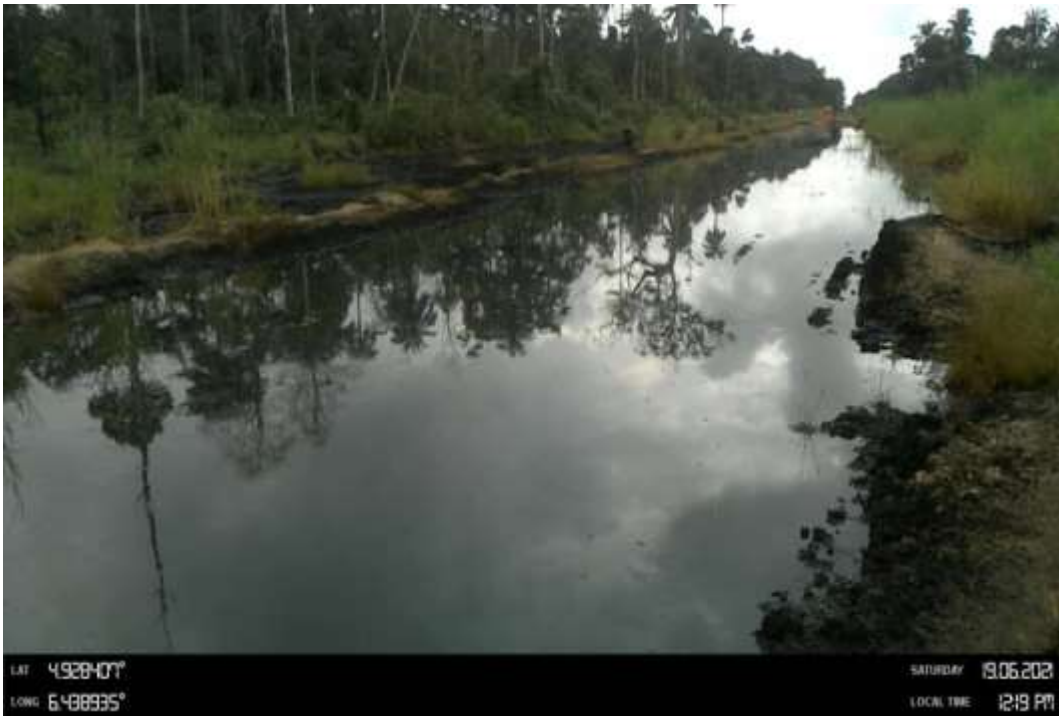
Overview: Part of spill impact on 20inch Kolocreek – Rumuekpe Pipeline at Odau. Picture was taken during Joint Investigation of 19th June 2021.

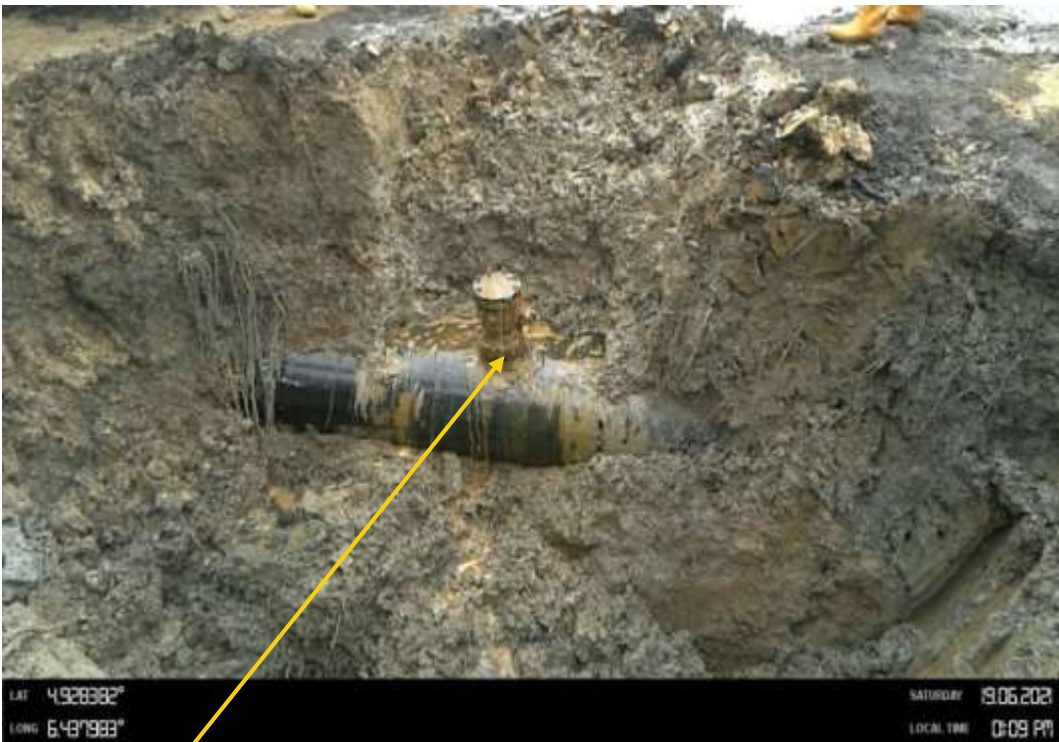
Close-up: 4inch illegal connection installed at 12 o'clock position on 20inch Kolocreek – Rumuekpe Pipeline at Odau. Picture was taken during Joint Investigation of 19th June 2021.
