INCIDENT NO: 2972655 JIV report S/N:0000789

A. GENERAL INFORMATION:		
1. Fountain Incident Number: 2972651	2. Type of incid	dent* OIL SPILL
3. Name of Location 20" KOLO CREE	K- RumuEKP	E PIPELINE
4. Name of nearest community ODAU	5. State: RWERS	6. LGA ABUA /OBUAL

7. Production Facility/Installation OIL Pre-	ELINE	
8. Asset Owner/Hub THE SHELL F NIGERIA LIMITA B. INCIDENT INFORMATION:	ETROLEUM DE ED (SPDC) / PIPO	sublopment Company of Fling

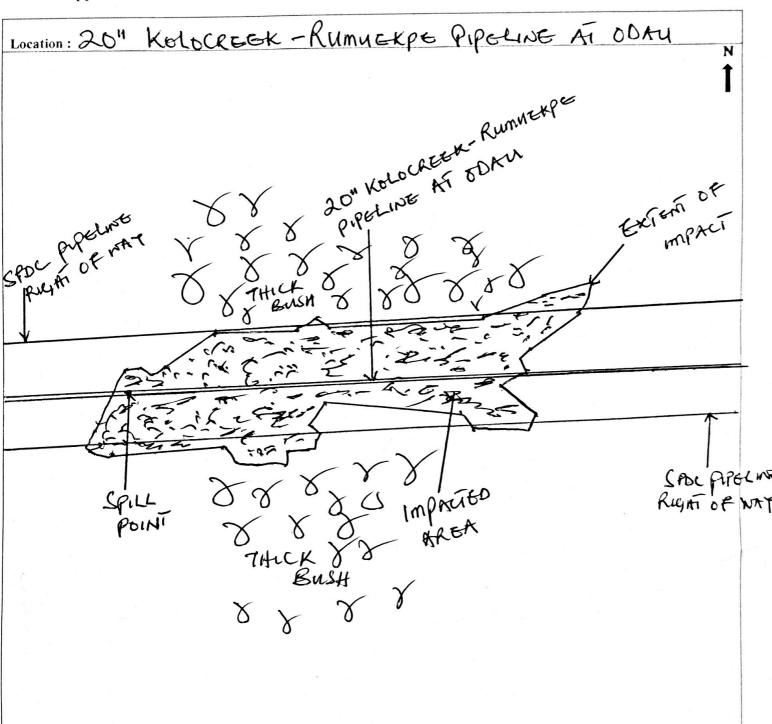
f. Appendix 1: Overview sketch of the site

20. Others (Specify) e.	g. Animal Traps	VA	REA	Of 1	MPACT
S/N Others	Description		Quantity/Size	Comments	
MONG	With	N	AREI	1 0+	IMPACT
E. GRAPHIC DESCRIPT in the leak report, overview - Rymyekpo Pipe	sketch of the site show	uld be added a	is appendix 1) <u> </u>	26010N	OF 204 KOLOCREE EGML CONNECTED
NSTALLED AT	12 6'clo		IVON B		
	4ª ULETAN				
	T'UIKIM
