# JOINT INVESTIGATION REPORT

INCIDENT NO: 2975535 JIV report S/N: 0000869

1. Fountain Incident Number: 2975535 2. Type of incident\* OIL SPILL  
3. Name of Location 12" IMORWERI - OGALE PIPELINE  
4. Name of nearest community OWAZA 5. State: ABIA 6. LGA UKWA WEST  
7. Production Facility/Installation PIPELINE  
8. Asset Owner/Hub THE SHELL PETROLEUM DEVELOPMENT COMPANY OF NIGERIA LIMITED (SPDC)/PIPELINE

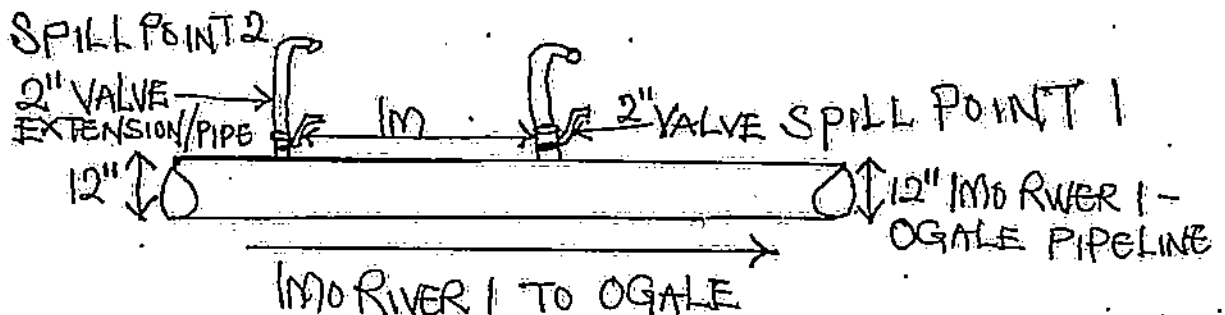
**E. GRAPHIC DESCRIPTION OF LEAK POINT** (while detailed description of the leak point should be contained in the leak report, overview sketch of the site should be added as appendix 1) A SECTION OF 12" (IMD RIVER) OGALE PIPELINE AT OWAZA SHOWING 2 NOS 2" BALL VALVES OF 1M APART. INSTALLED AT 12 O'CLOCK POSITION BY UNKNOWN PERSONS.

REPAIR BY CLAMPING
