JOINT INVESTIGATION REPORT

INCIDENT NO: 2968758 JIV report S/N: 0000840

1. Fountain Incident Number: 2968758 2. Type of incident*: OIL SPILL
3. Name of Location: 20" KOLA-CREEK RUNWEGE TRUNKLINE AT OKPOROWO
4. Name of nearest community: OKPOROWO 5. State: RIVERS 6. LGA: ATHOADA EAST
7. Production Facility/Installation: CRUDE OIL PIPELINE
8. Asset Owner/Hub: SHELL PETROLEUM DEVELOPMENT COMPANY
(PIPELINE)

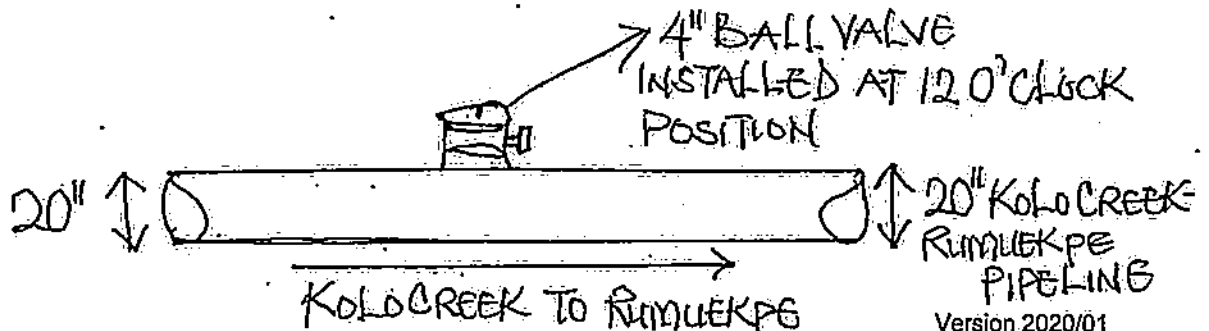
E. GRAPHIC DESCRIPTION OF LEAK POINT (while detailed description of the leak point should be contained

| <input checked="" type="checkbox"/> Crude oil theft (illegal bunkering) point, | <input type="checkbox"/> Saver-pit over flow | <input type="checkbox"/> Third party tampering with Clamp |

in the leak report, overview sketch of the site should be added as appendix 1) A SECTION OF 20" KOLO CREEK - RUMUEKPE PIPE LINE AT OKPOROKO SHOWING A 4" BALL VALVE INSTALLED AT 12 O' CLOCK POSITION BY UNKNOWN PERSON(S)
