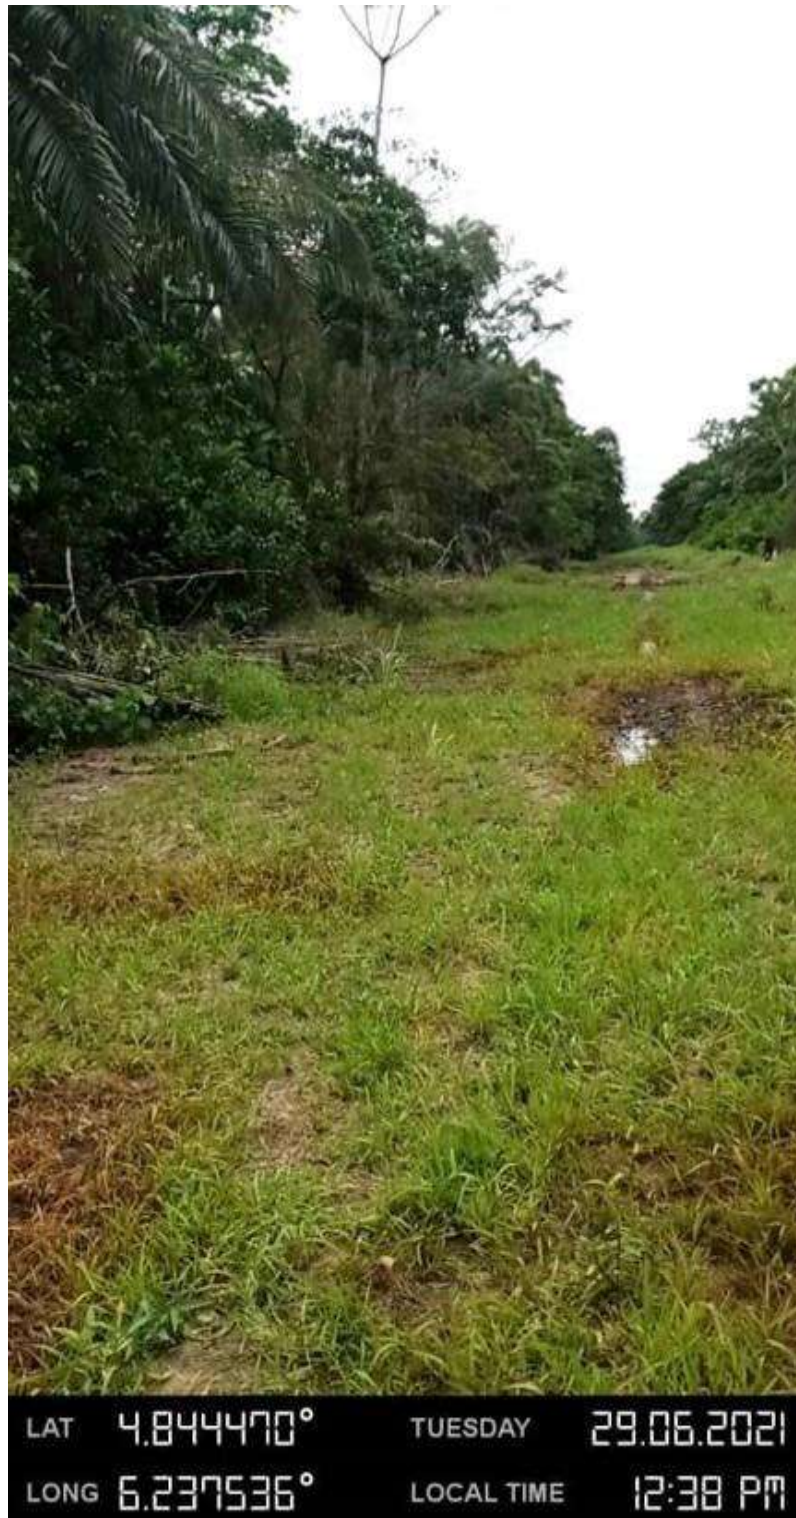
Overview: Part of spill impact on 16inch Nun-River to Kolocreek Pipeline at Otuegwe Picture was taken during Joint Investigation of 29<sup>th</sup> June 2021.

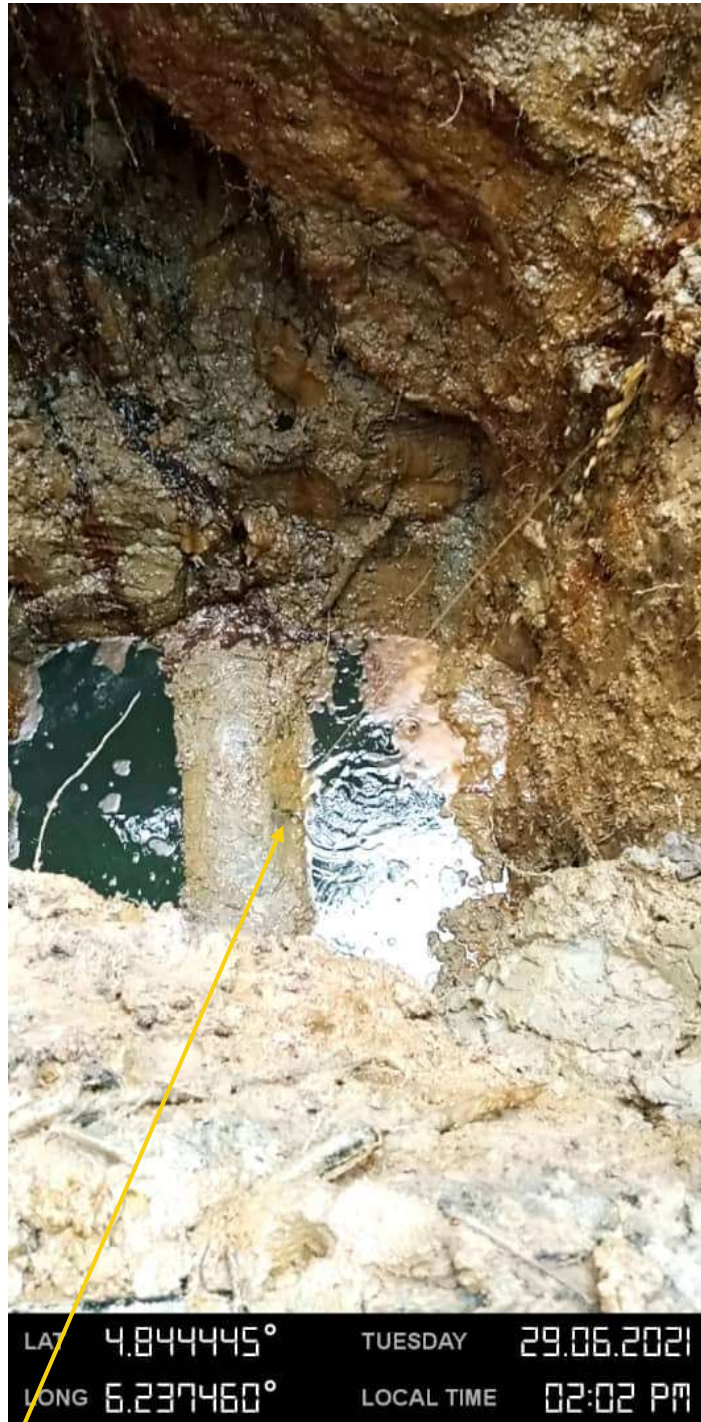
Close-up: Hacksaw cut (2cm length) at 1 o'clock position on 16inch Nun-River to Kolocreek Pipeline at Otuegwe Picture was taken during Joint Investigation of 29<sup>th</sup> June 2021.
