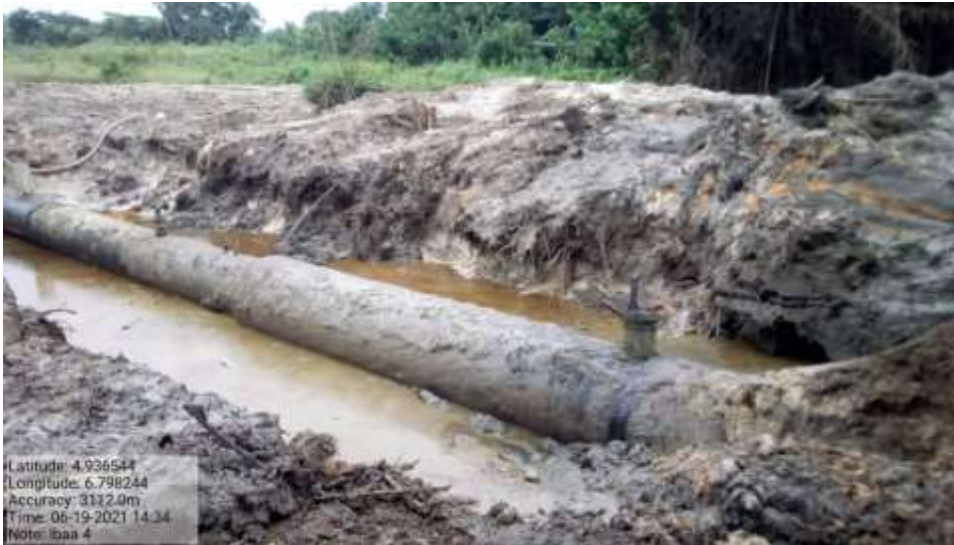
Overview: Part of spill impact on 36inch Rumuekpe Nkpoku Pipeline at Ibaa.  
Picture was taken during Joint Investigation of 19<sup>th</sup> June 2021.

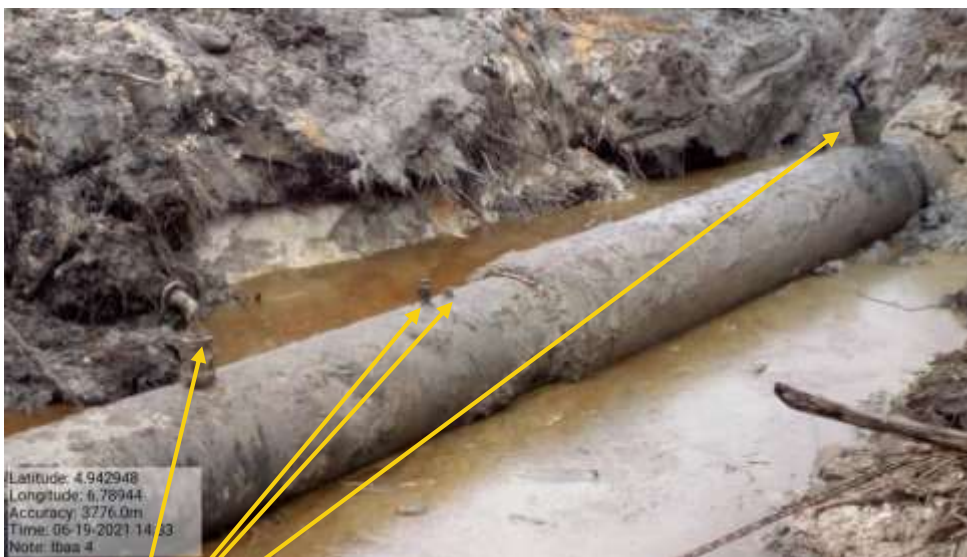
Close-up: 4nos crude oil theft points at 12 o'clock position on 36inch Rumuekpe Nkpoku Pipeline at Ibaa. Picture was taken during Joint Investigation of 19<sup>th</sup> June 2021.
