JOINT INVESTIGATION REPORT

INCIDENT NO: 2972821 JIV report S/N: 0000890

1. Fountain Incident Number: 2972821 2. Type of incident* OIL SPILL
3. Name of Location 36" Rumuhoje - Mkpoku PIPELINE
4. Name of nearest community IBAA 5. State: RIVERS 6. LGA EMOHUA
7. Production Facility/Installation CRUDE OIL PIPELINE
8. Asset Owner/Hub THE SHELL PETROLEUM DEVELOPMENT COMPANY OF NIGERIA LIMITED / PIPELINE

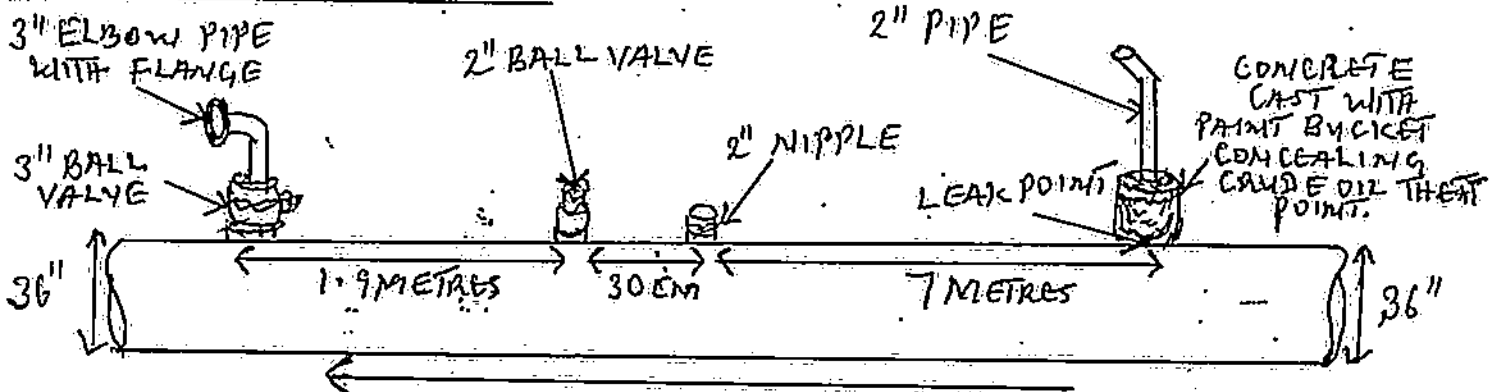
SECTION OF 36" RUMUETKE - NIPOICU PIPELINE AT BAA SHOWING 4 NOS OF CRUDE OIL THEFT POINTS INSTALLED AT 12 O'CLOCK POSITIONS BY UNKNOWN PERSONS.

← FROM RUMUETKE TO NIPOICU
