JOINT INVESTIGATION REPORT

INCIDENT NO: 2973890 JIV report S/N: 0000885

1. Fountain Incident Number: 2973890 2. Type of incident* OIL SPILL
3. Name of Location ADIBAKA NORTH EAST (ADNE) WELL 1 FLOWLINE
4. Name of nearest community BISENI 5. State: BAYELSA 6. LGA YENAGOA
7. Production Facility/Installation FLOWLINE
8. Asset Owner/Hub THE SHELL PETROLEUM DEVELOPMENT COMPANY OF NIGERIA LIMITED (SPDC) / CENTRAL HUB

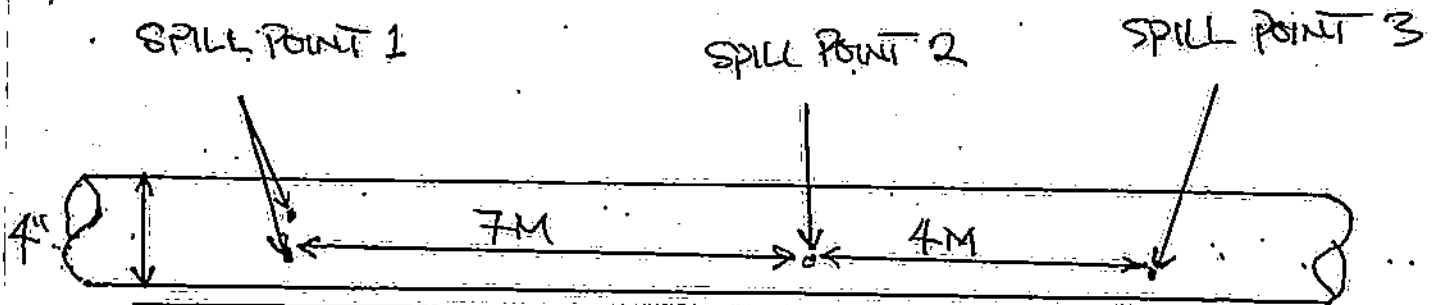
E. GRAPHIC DESCRIPTION OF LEAK POINT (while detailed description of the leak point should be contained in the leak report, overview sketch of the site should be added as appendix 1) A SECTION ADNE WELL 1 FLOWLINE AT BISENI SHOWING 3 NOS SPILL POINTS (PUNCTURE) CAUSED BY UNKNOWN PERSON(S).

FROM ADNE WELL 1 TO ADIBAWA MFD
