# JOINT INVESTIGATION REPORT

INCIDENT NO: 2885720 JIV report S/N: 0000766

1. Fountain Incident Number: 2885720 2. Type of incident\* OIL SPILL  
3. Name of Location 14" OKORDIA - RUMUEKPE PIPELINE  
4. Name of nearest community EDEOKA 5. State: RIVERS 6. LGA AKHADA EAST  
7. Production Facility/Installation PIPELINE  
8. Asset Owner/Hub THE SHELL PETROLEUM DEVELOPMENT COMPANY OF NIGERIA LIMITED (SPDC)/PIPELINE

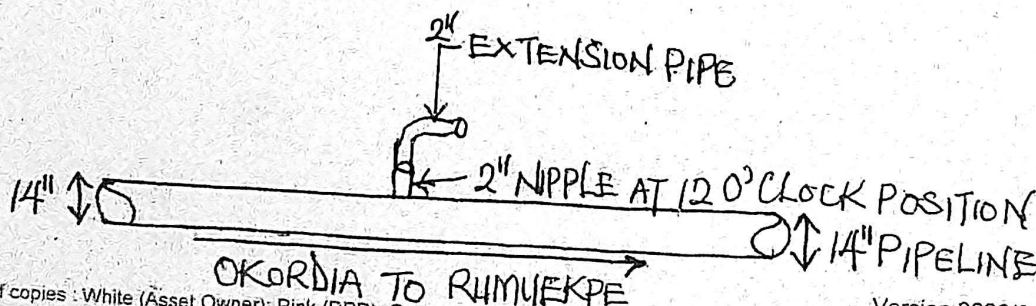
E. GRAPHIC DESCRIPTION OF LEAK POINT (while detailed description of the leak point should be contained in the leak report, overview sketch of the site should be added as appendix 1)

-RUMUEKPE PIPELINE AT EDEOHA SHOWING A 2" NIPPLE INSTALLED AT 12 O'CLOCK POSITION BY UNKNOWN PERSON(S).

REPAIR BY CLAMPING
