# JOINT INVESTIGATION REPORT

INCIDENT NO: 2885750 JIV report S/N: 0000780

1. Fountain Incident Number: 2885750 2. Type of incident\* OIL SPILL  
3. Name of Location 8" SIMIRI - IMOGATE PIPELINE  
4. Name of nearest community UMUELECHI 5. State: ABIA 6. LGA UKWA WEST  
7. Production Facility/Installation CRUDE OIL PIPELINE  
8. Asset Owner/Hub THE SHELL PETROLEUM DEVELOPMENT COMPANY  
OF NIGERIA LIMITED / PIPELINE

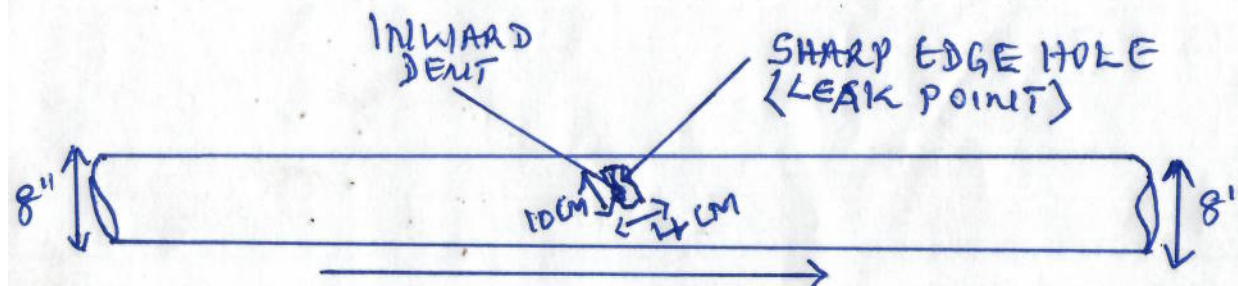
| <input type="checkbox"/> Complete Rupture | <input checked="" type="checkbox"/> Inward dent, | <input type="checkbox"/> Well head tampering |
| <input checked="" type="checkbox"/> Others (specify) <u>SHARP EDGE HOLE</u> | | |

- ☒ Third party interference (Sabotage ☒; crude theft ☐; Line theft ☐; Accidental 3<sup>rd</sup> party damage ☐  
☐ Operational ☐ Others (including Mystery spills) \_\_\_\_\_

SECTION OF 8" ISIMIRI - IMOATE PIPELINE AT UMUELECHI  
SHOWING INWARD DENT AND SHARP EDGE HOLE BETWEEN  
10 O'CLOCK TO 11 O'CLOCK POSITION.

FROM ISIMIRI TO IMOATE

REPAIR WORK ONGOING.
