Overview: Part of spill impact on 4inch (Bulkline) Well 4 Flowline at Biseni.  
Picture was taken during Joint Investigation of 22<sup>nd</sup> March 2021.

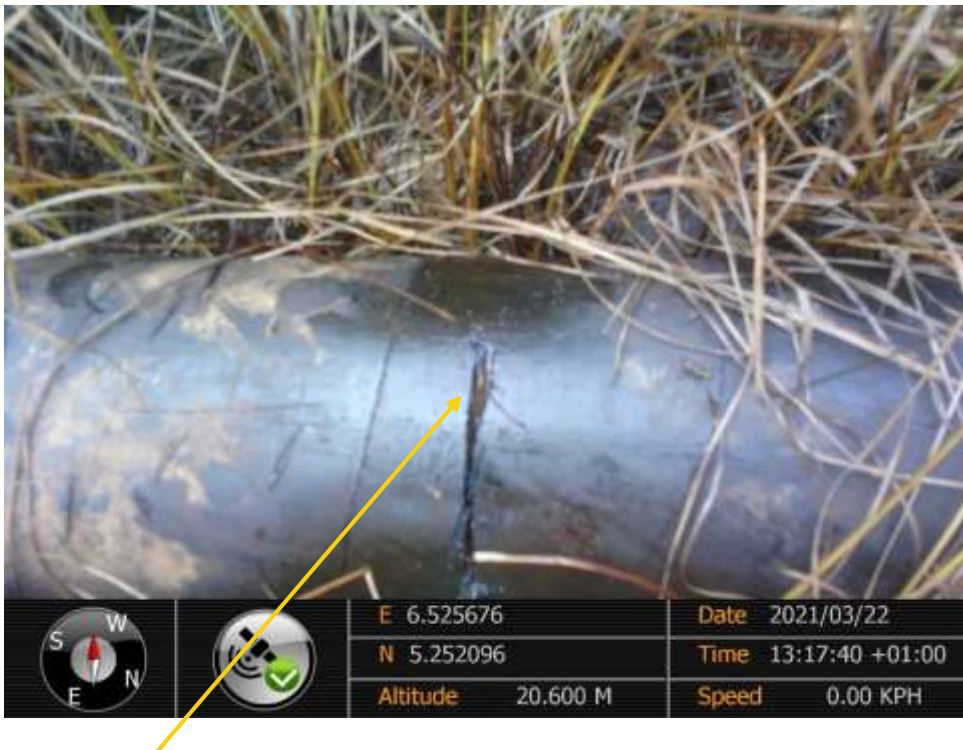
Close-up: SP 1: Hacksaw cut from 10-12 o'clock position on 4inch (Bulkline) well 4 Flowline at Biseni. Picture was taken during Joint Investigation of 22<sup>nd</sup> March 2021.

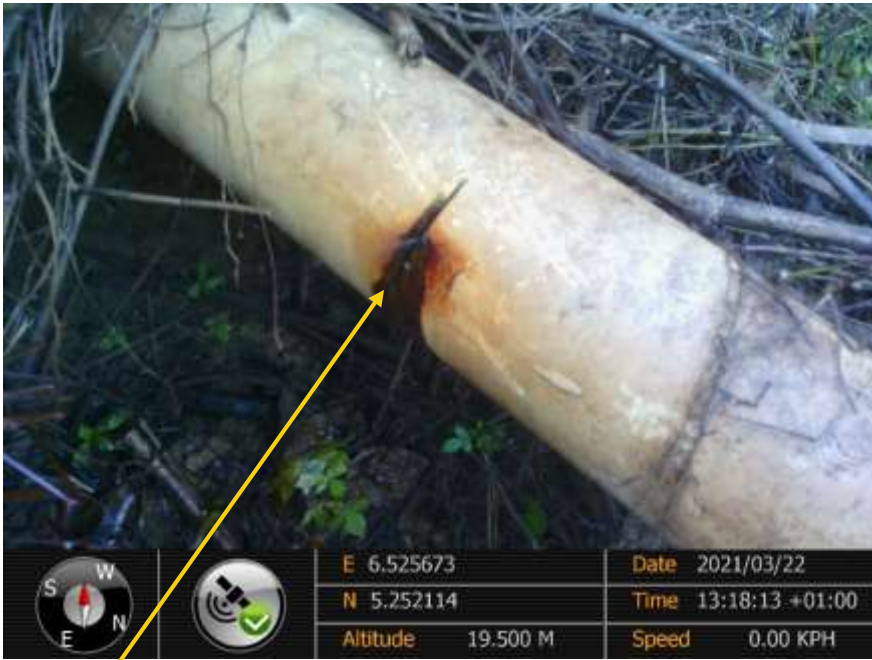
Closeup: SP 2 Hacksaw cut from 9-11 o'clock position on 4inch (Bulkline) well 4 Flowline at Biseni. Picture was taken during Joint Investigation of 22<sup>nd</sup> March 2021.
