JOINT INVESTIGATION REPORT

INCIDENT NO: 2890855 JIV report S/N: 0000798

1. Fountain Incident Number: 2890855 2. Type of incident* OIL SPILL
3. Name of Location 28" BOMU - BONNY PIPELINE
4. Name of nearest community OWOKIRI 5. State: RIVERS 6. LGA ANDONI
7. Production Facility/Installation CRUDE OIL PIPELINE
8. Asset Owner/Hub THE SHELL PETROLEUM DEVELOPMENT COMPANY
OF NIGERIA LIMITED / PIPELINE

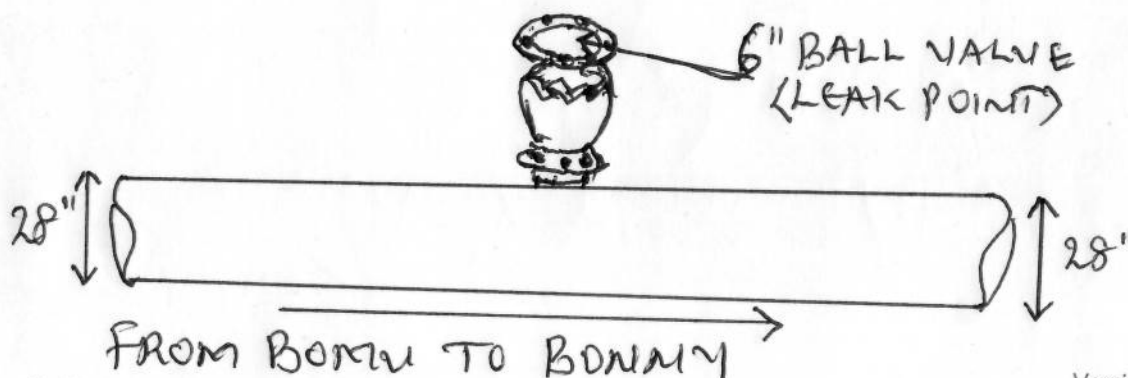
E. GRAPHIC DESCRIPTION OF LEAK POINT (while detailed description of the leak point should be contained in the leak report, overview sketch of the site should be added as appendix 1)

Additional observations around the spill point: THE SPILL INCIDENT RESULTED FROM AN ALREADY REPORTED ILLEGAL CONNECTION(IC) WITH INCIDENT NUMBER 2885201

| <input checked="" type="checkbox"/> Failed Weld-on illegal hot tap valve | <input type="checkbox"/> Failed Clamp, | <input type="checkbox"/> Missing Pipeline/Flowline |
| <input checked="" type="checkbox"/> Crude oil theft (illegal bunkering) point, | <input type="checkbox"/> Saver-pit over flow | <input type="checkbox"/> Third party tampering with Clamp |

SECTION OF 28" BOMU - BONNY PIPELINE AT OWOKIRI SHOWING
CRUDE OIL LEAK POINT INSTALLED AT 12 O'CLOCK POSITION BY
UNKNOWN PERSONS.

REPAIR ACTIVITIES ONGOING

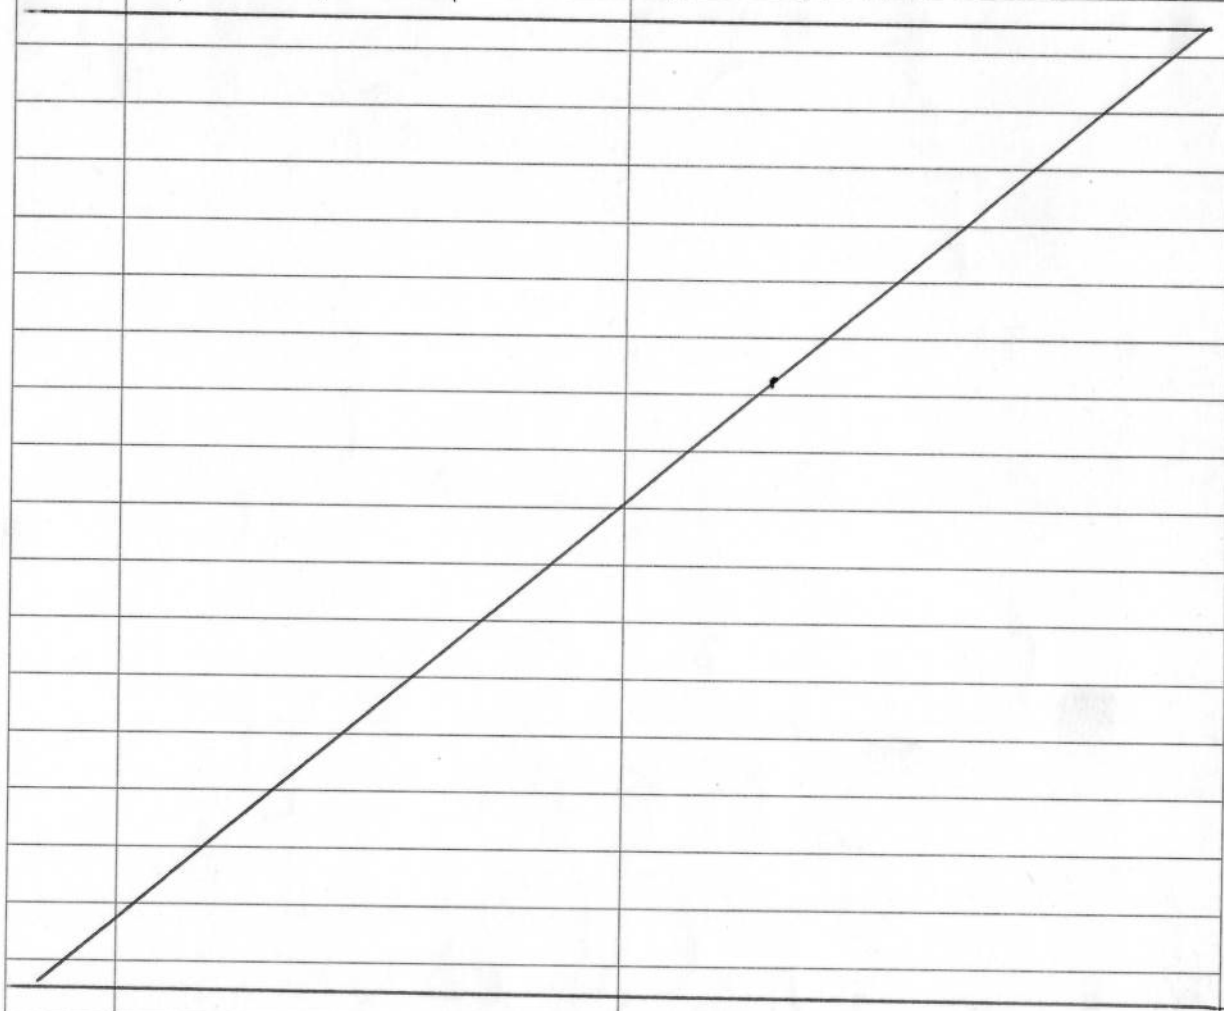
F: TABLE SHOWING SOME OF COORDINATES TAKEN DURING JIV FOR AREA CALCULATION

S/N	Northing	Easting
1	4.54237	7.24619
2	4.54236	7.24622
3	4.54234	7.24622
4	4.54231	7.24619
5	4.54234	7.24618

- Total calculated area of impact (Ha) 0.002 HA
- Impact within SPDC R.O.W YES
- Impact outside SPDC R.O.W NO
