JOINT INVESTIGATION REPORT

INCIDENT NO: 2896754 JIV report S/N: 0000828

1. Fountain Incident Number: 2896754 2. Type of incident* OIL SPILL
3. Name of Location 4" MKALI WELL 13 L/S FLOWLINES
4. Name of nearest community ODAGWA 2 5. State: RIVERS 6. LGA ETCITE
7. Production Facility/Installation CRUDE OIL FLOWLINES
8. Asset Owner/Hub THE SHELL PETROLEUM DEVELOPMENT COMPANY OF NIGERIA LIMITED / LAND EAST HUB.

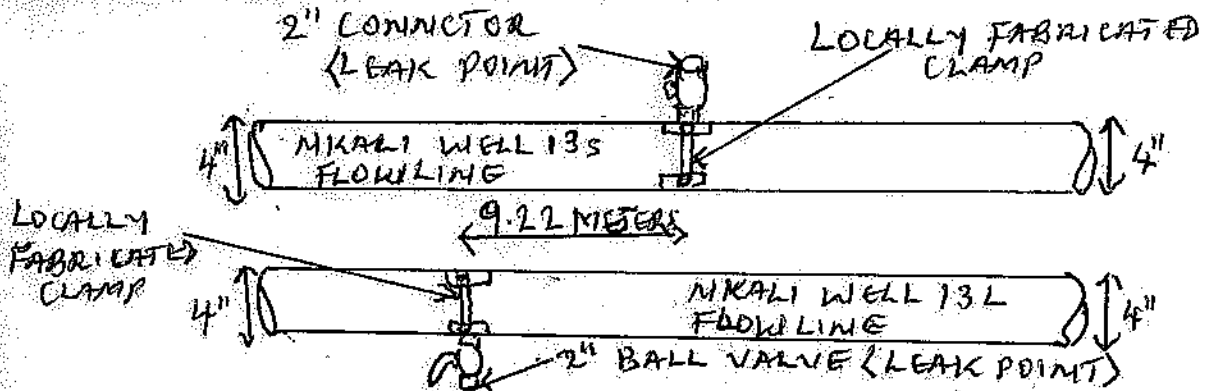
SECTION OF 4" NIKALI WELL 13 L/S FLOWLINE AT ODAGWIA SHOWING CRUDE OIL THEFT POINTS INSTALLED AT 3 O'CLOCK AND 9 O'CLOCK POSITIONS BY UNKNOWN PERSONS

FROM NIKALI WELL 13 L/S TO NIKALI FLOW STATION

| <input checked="" type="checkbox"/> Failed Weld-on illegal hot tap valve | <input type="checkbox"/> Failed Clamp, | <input type="checkbox"/> Missing Pipeline/Flowline |
| <input checked="" type="checkbox"/> Crude oil theft (illegal bunkering) point, | <input type="checkbox"/> Saver-pit over flow | <input type="checkbox"/> Third party tampering with Clamp |
