# JOINT INVESTIGATION REPORT

INCIDENT NO: 2896773 JIV report S/N: 0000827

1. Fountain Incident Number: 2896773 2. Type of incident\* OIL SPILL  
3. Name of Location 4" NKALI WELL 10S FLOWLINE  
4. Name of nearest community ODAGWA 5. State: RIVERS 6. LGA ETCITE  
7. Production Facility/Installation CRUDE OIL FLOWLINE  
8. Asset Owner/Hub THE SHELL PETROLEUM DEVELOPMENT COMPANY  
OF NIGERIA LIMITED / LAND EAST HUB

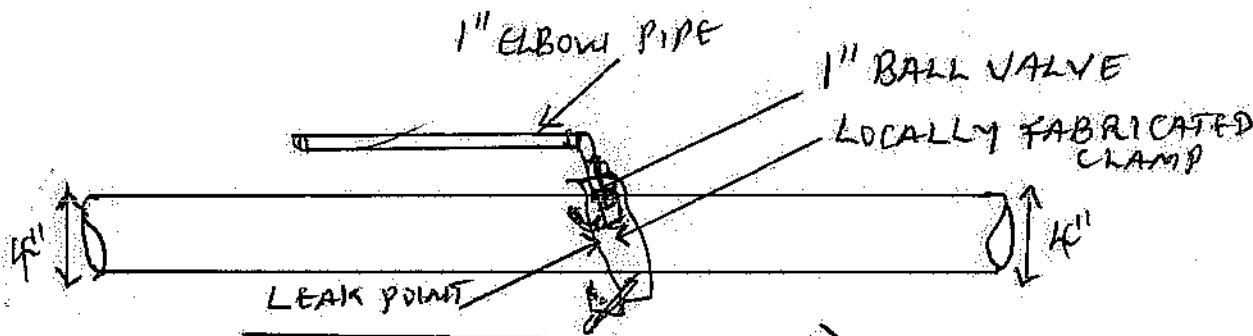
E. GRAPHIC DESCRIPTION OF LEAK POINT (while detailed description of the leak point should be contained in the leak report, overview sketch of the site should be added as appendix 1)

| <input checked="" type="checkbox"/> Failed Weld-on illegal hot tap valve | <input type="checkbox"/> Failed Clamp, | <input type="checkbox"/> Missing Pipeline/Flowline |
| <input checked="" type="checkbox"/> Crude oil theft (illegal bunkering) point, | <input type="checkbox"/> Saver-pit over flow | <input type="checkbox"/> Third party tampering with Clamp |

SECTION OF 4" NKALI WELL 10S FLOWLINE AT ODAGWA SHOWING CRUDE OIL THEFT POINT INSTALLED AT 12 O'CLOCK POSITION BY UNKNOWN PERSONS.

FROM NKALI WELL 10S TO NKALI FLOWSTATION
