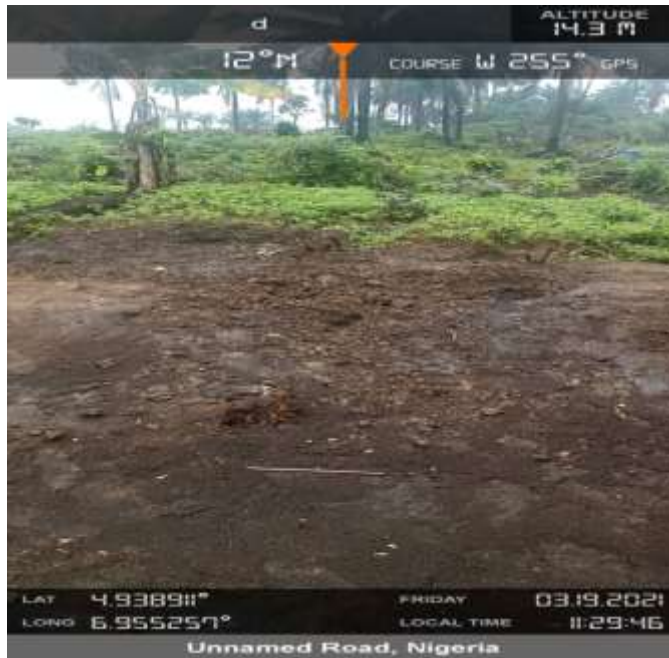
Overview: Part of spill impact on 20inch Rumuekpe Nkpoku Trunkline at Mbodo Aluu. Picture was taken during Joint Investigation of 19<sup>th</sup> March 2021.

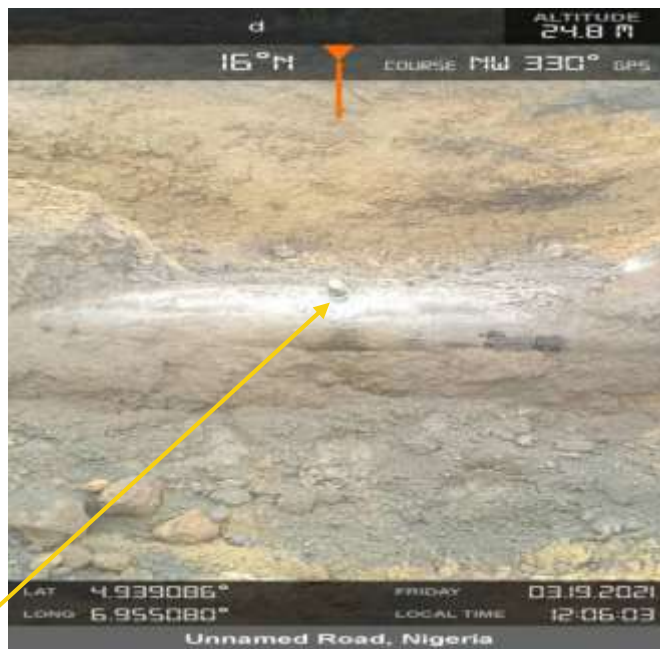
Close-up: 2inch illegal connection installed at 12 o'clock on 20inch Rumuekpe Nkpoku Trunkline at Mbodo Aluu. Picture was taken during Joint Investigation of 19<sup>th</sup> March 2021.
