JOINT INVESTIGATION REPORT

INCIDENT NO: 2889953 JIV report S/N: 0000799

1. Fountain Incident Number: 2889953 2. Type of incident* OIL SPILL
3. Name of Location 20" RUMUEKPE - NIKPOKU TRUNKLINE (PIPELINE)
4. Name of nearest community MBODO-ALUU 5. State: RIVERS 6. LGA IKWERRE
7. Production Facility/Installation PIPELINE
8. Asset Owner/Hub THE SHELL PETROLEUM DEVELOPMENT COMPANY OF NIGERIA LIMITED (SPDC) / PIPELINE

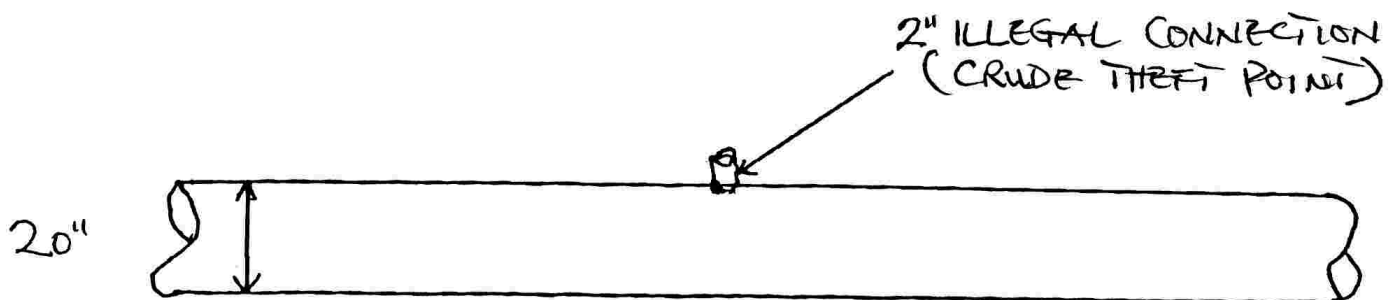
E. GRAPHIC DESCRIPTION OF LEAK POINT (while detailed description of the leak point should be contained in the leak report, overview sketch of the site should be added as appendix 1) A SECTION 20" RUMUEKPE - NKPOKU TRUNKLINE (PIPELINE) AT MBODO - ALUO SHOWING A 2" ILLEGAL CONNECTION INSTALLED AT 12 O'CLOCK POSITION BY UNKNOWN PERSON(S)

FROM RUMUEKPE - NKPOKU MANIFOLD Version 2020/01

REPAIR BY CLAMPING ONGOING.
