# JOINT INVESTIGATION REPORT

INCIDENT NO: 2896227 JIV report S/N: 0000834

1. Fountain Incident Number: 2896227 2. Type of incident\* OIL SPILL  
3. Name of Location 3" IMO RIVER WELL G3T  
4. Name of nearest community OWAZA 5. State: ABIA 6. LGA UKIWA WEST  
7. Production Facility/Installation FLOWLINE  
8. Asset Owner/Hub THE SHELL PETROLEUM DEVELOPMENT COMPANY OF NIGERIA LIMITED (SPDC)/LAND EAST HUB

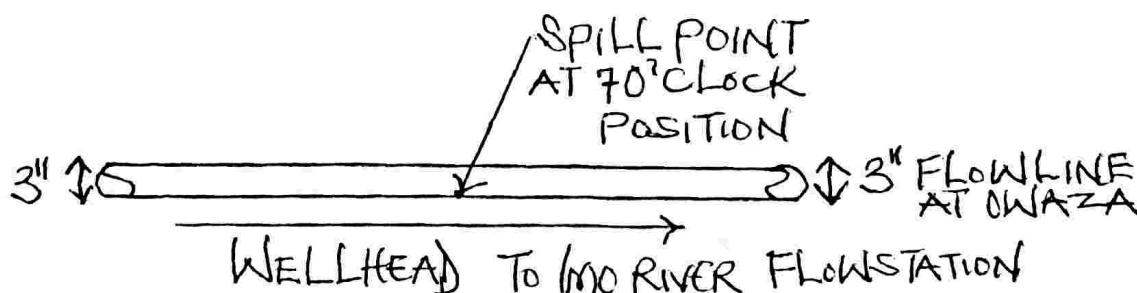
E. GRAPHIC DESCRIPTION OF LEAK POINT (while detailed description of the leak point should be contained in the leak report, overview sketch of the site should be added as appendix 1)

- e. Description of leak point (tick as applicable);  
☐ Smooth round-edge hole ☒ Rough-edge hole ☐ Hack saw cut  
☐ Complete Rupture ☐ Inward dent, ☐ Well head tampering  
☐ Failed Weld-on illegal hot tap valve ☐ Failed Clamp, ☐ Missing Pipeline/Flowline  
☐ Crude oil theft (illegal bunkering) point, ☐ Saver-pit over flow ☐ Third party tampering with Clamp  
☐ Third party tampering with valve setting ☐ Bulging Outward ☐ Third party tampering with flange,  
☐ Flare System/Bund wall failure ☐ Cold vent ☐ Surge vessel overflow,  
☐ Valve Failure ☐ Relief valve failure ☐ Accidental 3<sup>rd</sup> party equipment impact  
☐ Tear ( )  
☒ Others (specify) PIN HOLE (ROUGH-EDGE)
- f. Incident caused by:  
☐ Third party interference (Sabotage ☐; crude theft ☐; Line theft ☐; Accidental 3<sup>rd</sup> party damage ☐  
☒ Operational ☐ Others (including Mystery spills) \_\_\_\_\_

A SECTION OF 3" IM6 RIVER FLOWLINE (WELL 63T) AT OWAZA SHOWING A PINHOLE AT 7 O'CLOCK POSITION
