JOINT INVESTIGATION REPORT

INCIDENT NO: 2937728 JIV report S/N: 0000772

1. Fountain Incident Number: 2937728 2. Type of incident* OIL SPILL
3. Name of Location 12" IMO RIVER 2 - OGAE PIPELINE
4. Name of nearest community ODAGWA 5. State: RIVERS 6. LGA ETCHE
7. Production Facility/Installation PIPELINE
8. Asset Owner/Hub THE SHELL PETROLEUM DEVELOPMENT COMPANY
OF NIGERIA LIMITED (SPDC) / PIPELINE

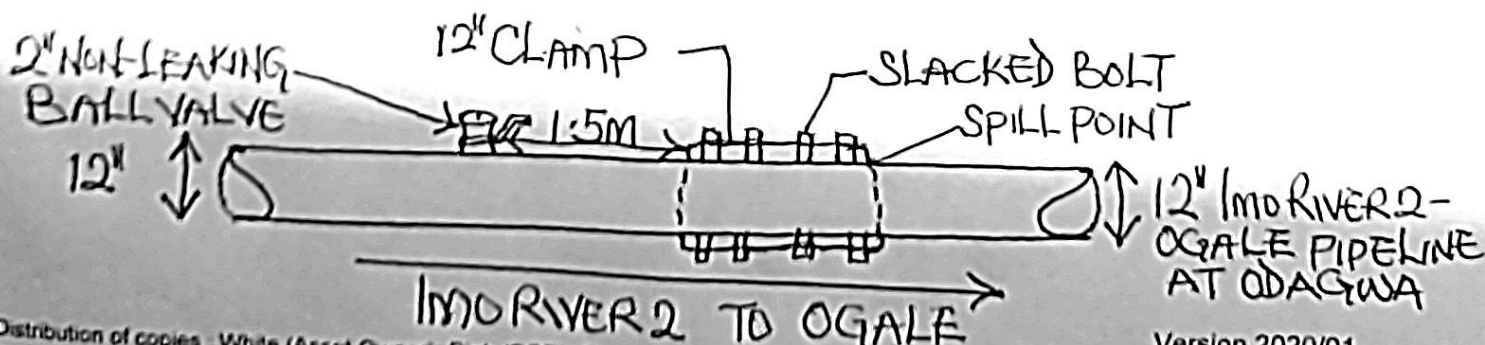
A 2" NON-LEAKING BALL VALVE WAS INSTALLED AT 12 O' CLOCK POSITION. THE DISTANCE BETWEEN THE ILLEGAL CONNECTION (IC) AND THE TAMPED CLAMP IS 1.5M.

E. GRAPHIC DESCRIPTION OF LEAK POINT (while detailed description of the leak point should be contained in the leak report, overview sketch of the site should be added as appendix 1) A SECTION OF 12" IMORIVER 2 -OGALE PIPELINE AT ODAGWA SHOWING THIRD PART/ TAMPERING WITH CLAMP. ALSO 1.5M DISTANCE FROM THE CLAMP IS A NEWLY INSTALLED 2" NON LEAKING BALL VALVE (IC) AT 12 O'CLOCK POSITION BY UNKNOWN PERSON(S).

REPAIR BY CLAMPING

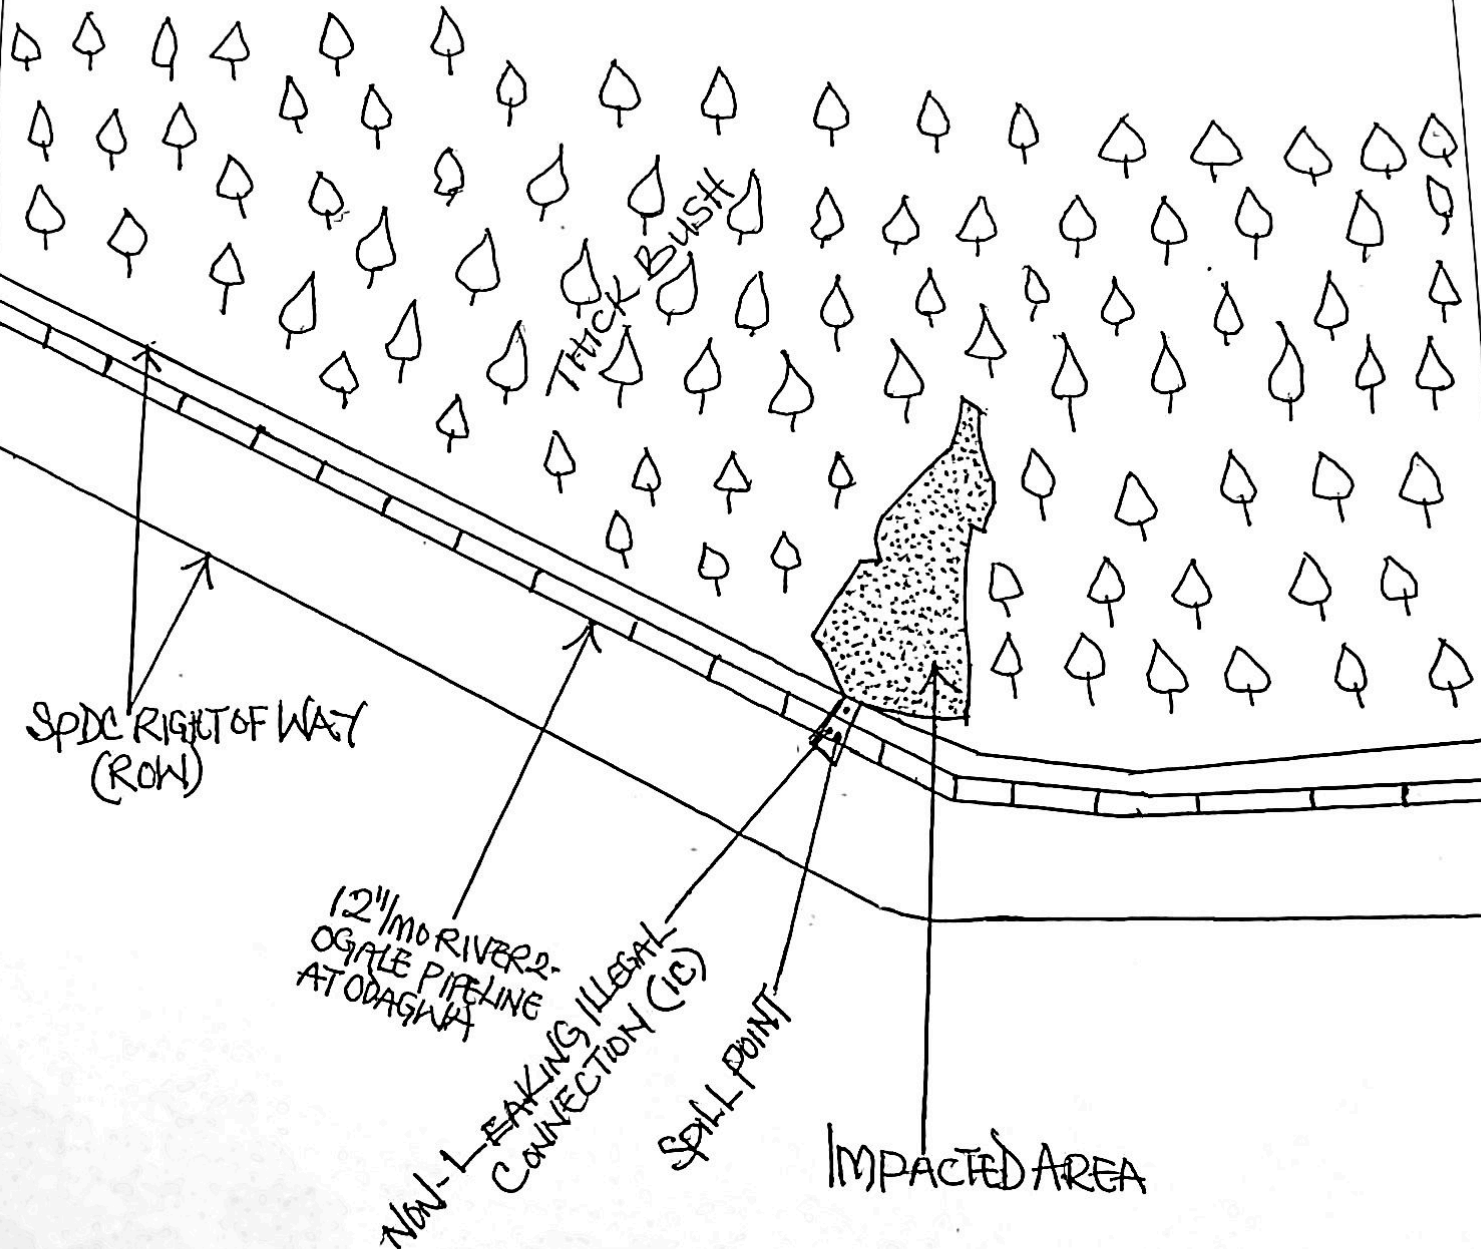
f. Appendix 1: Overview sketch of the site

Location : 12" MO RIVER 2-OGALE PIPELINE AT ODAGWA
