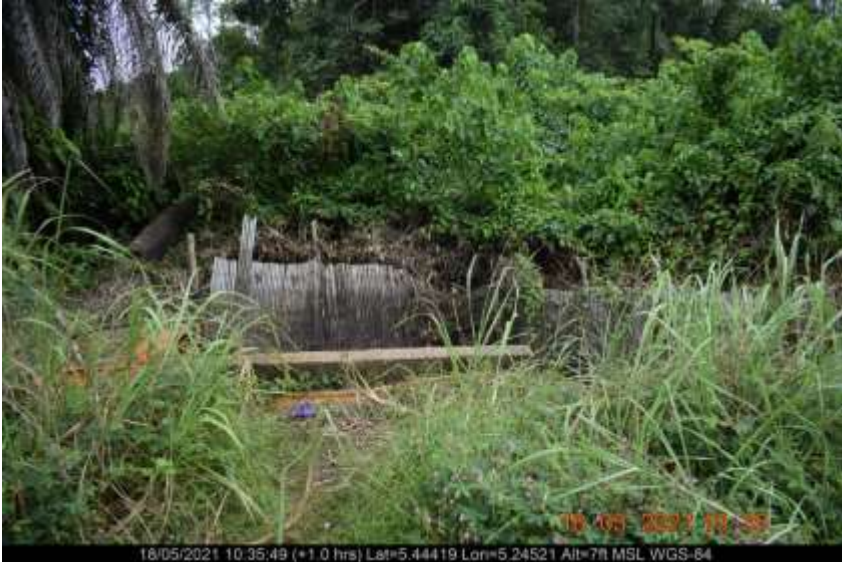
Overview: Part of spill impact on 4inch Yokri Well 111T Flowline at Yokri .
Picture was taken during Joint Investigation of 18th May 2021.

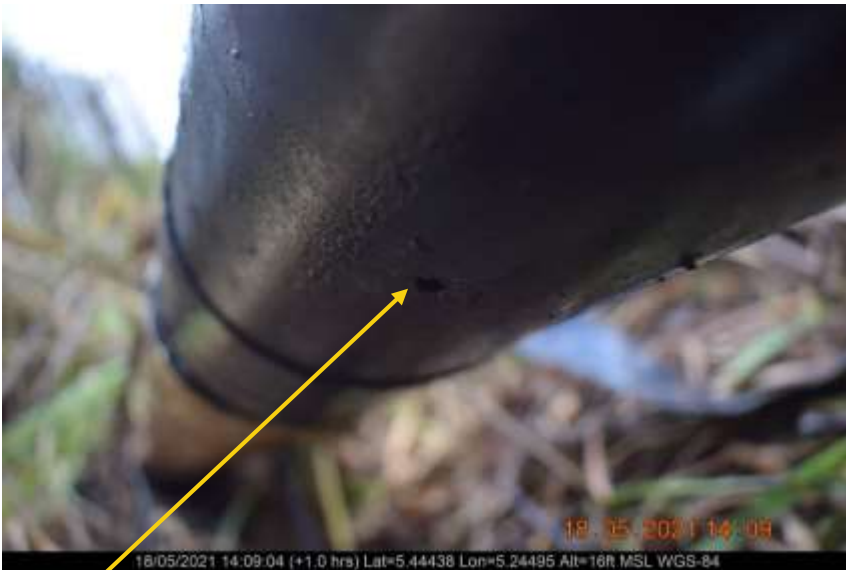
Close-up: Pinhole at 7 o'clock position on 4inch Yokri Well 111T Flowline at Yokri . Picture was taken during Joint Investigation of 18th May 2021.
