JOINT INVESTIGATION REPORT

INCIDENT NO: 2947192 JIV report S/N: 0000864

1. Fountain Incident Number: 2947192 2. Type of incident* OIL SPILL
3. Name of Location 16" EGBEMA - ASSA PIPELINE
4. Name of nearest community ORILE 5. State: IMO 6. LGA OHATI-EGBEMA
7. Production Facility/Installation PIPELINE
8. Asset Owner/Hub THE SHELL PETROLEUM DEVELOPMENT COMPANY OF NIGERIA LIMITED (SPDC)/PIPELINE

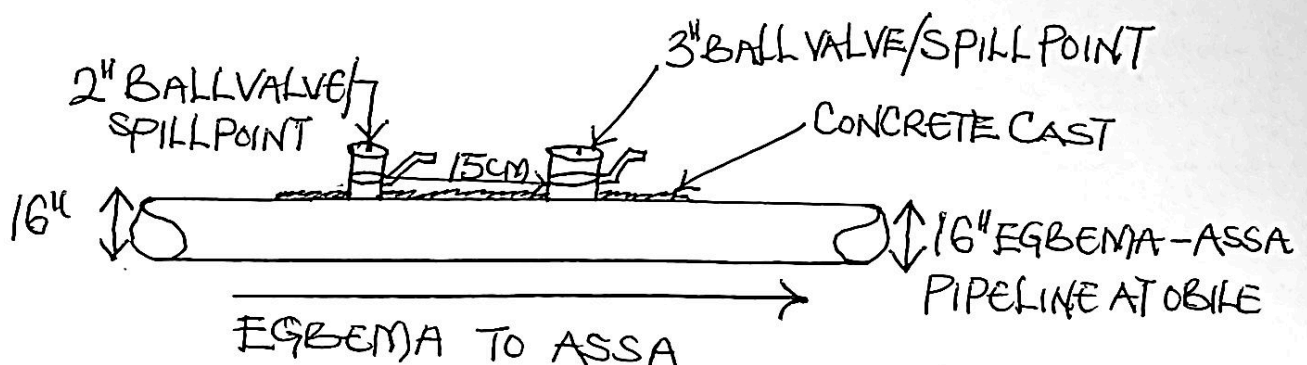
| <input checked="" type="checkbox"/> Crude oil theft (illegal bunkering) point, | <input type="checkbox"/> Saver-pit over flow | <input type="checkbox"/> Third party tampering with Clamp |
| <input checked="" type="checkbox"/> Third party tampering with valve setting | <input type="checkbox"/> Bulging Outward | <input type="checkbox"/> Third party tampering with flange, |

E. GRAPHIC DESCRIPTION OF LEAK POINT (while detailed description of the leak point should be contained in the leak report, overview sketch of the site should be added as appendix 1) A SECTION OF 16" EGBEMA-ASSA PIPELINE AT OBILE SHOWING 3" AND 2" BALL VALVES INSTALLED AT 12 O'CLOCK POSITION BY UNKNOWN PERSON(S).

REPAIR BY CLAMPING
