# JOINT INVESTIGATION REPORT

INCIDENT NO: 2948161 JIV report S/N: 0000865

1. Fountain Incident Number: 2948161 2. Type of incident\* OIL SPILL  
3. Name of Location 16<sup>th</sup> EGBAMA - ASSA PIPELINE  
4. Name of nearest community OBILE 5. State: IMO 6. LGA OHATI - EGBEMA  
7. Production Facility/Installation PIPELINE  
8. Asset Owner/Hub THE SHELL PETROLEUM DEVELOPMENT COMPANY OF NIGERIA LIMITED (SPDC)/PIPELINE

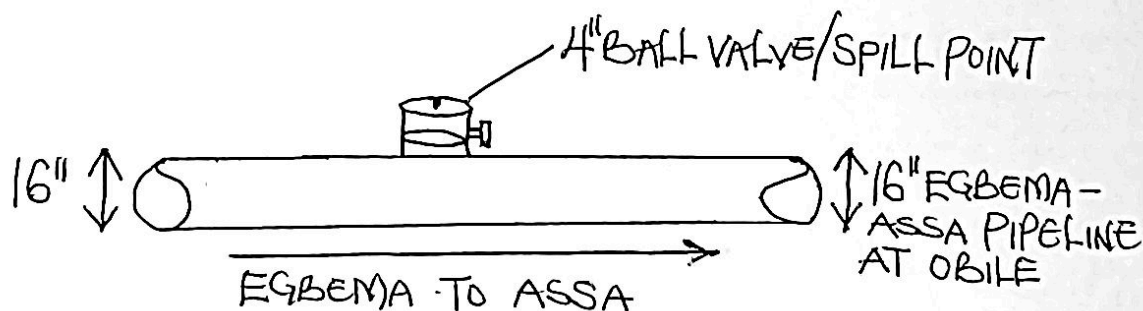
THE OIL SPILL WAS ACCOMPANIED BY FIRE.

| <input checked="" type="checkbox"/> Crude oil theft (illegal bunkering) point, | <input type="checkbox"/> Saver-pit over flow | <input type="checkbox"/> Third party tampering with Clamp |

- ☒ Third party interference (Sabotage ☐; crude theft ☒; Line theft ☐; Accidental 3<sup>rd</sup> party damage ☐  
☐ Operational ☐ Others (including Mystery spills) \_\_\_\_\_

E. GRAPHIC DESCRIPTION OF LEAK POINT (while detailed description of the leak point should be contained in the leak report, overview sketch of the site should be added as appendix 1) A SECTION OF 16" EGBEMA-ASSA PIPELINE AT OBILE SHOWING 4" BALL VALVE INSTALLED AT 12 O'CLOCK POSITION BY UNKNOWN PERSON(S).

REPAIR BY CLAMPING AND CRUDE OIL RECOVERY
